Bulletin No.: PIC5761

Service Bulletin

Subject: Glove Compartment Light On Unwanted

Models: 2013 Chevrolet Malibu

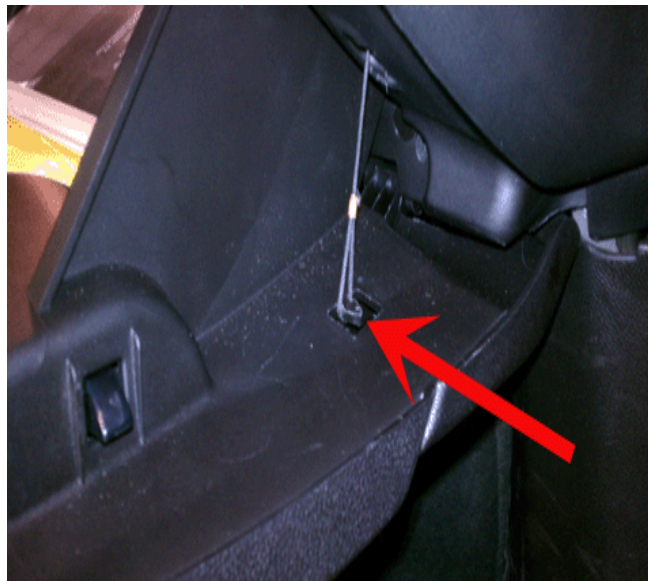
A customer or technician may comment the glove compartment light remains on with compartment closed or may notice it flickers off and on while driving.

Open glove compartment, disconnect the compartment damper, and apply inward pressure on either side of compartment in rear to disengage compartment stops. Now the compartment can be lowered and the harness for the light can now be disconnected to lower the compartment completely to access rear of compartment. You should see a witness mark where the compartment light pin switch contacts the back of the glove compartment. Apply a 1/8 to 1/4 inch thick patch to this location and reassemble glove compartment. Verify the compartment and light now function properly.
