Tech Tips

TT 15-12-01

2011-2012 3.6L Routan – Fault Codes P06DD, P000D, or P0390 After Cylinder Head Replacement

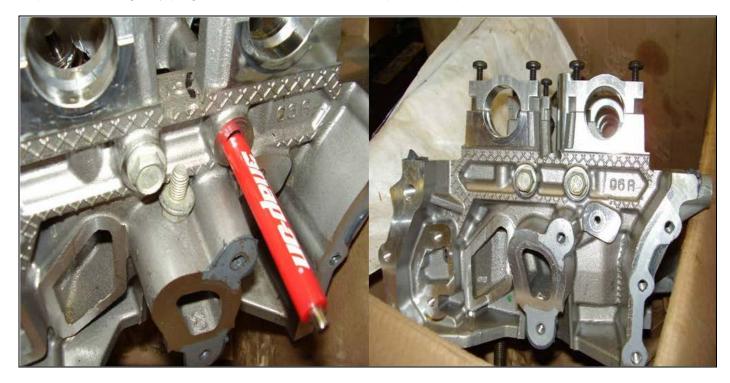
Verify that the oil galley bolts were transferred (see pictures below) when the cylinder head was replaced. Replacement oil galley plugs can also be ordered in a separate kit, part number 7B0198057.
