# Tech Tips

TT 20-12-03

## 2011-2013 Jetta Sedan Equipped With TDI Engine – Fuel Gauge Does Not Read Full after Fueling

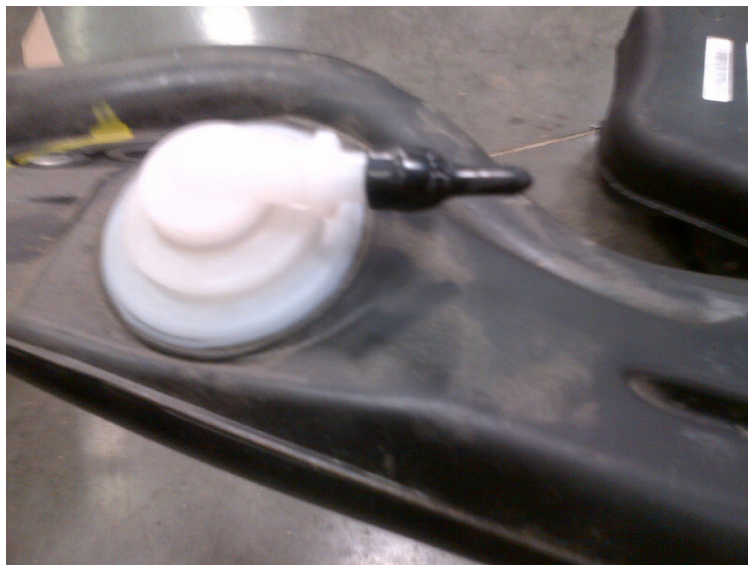
When diagnosing a customer concern of fuel gauge not reading full after fueling, start by checking for the presence of a cover over the fuel tank vent as shown in the picture below. Vent is located on filler neck and can be inspected by removing fuel door assembly. If cover is found over vent, remove and retest for customer concern. If cover is not present over vent, continue with normal diagnosis.
