Technical Bulletin

Model(s)	Year	Eng. Code	Trans. Code	VIN Range From	VIN Range To
Passat	2012-2013	All	All	All	All

94 12 02 October 8, 2012 **2031039**

Daytime Running Lamp Bulb Inoperative

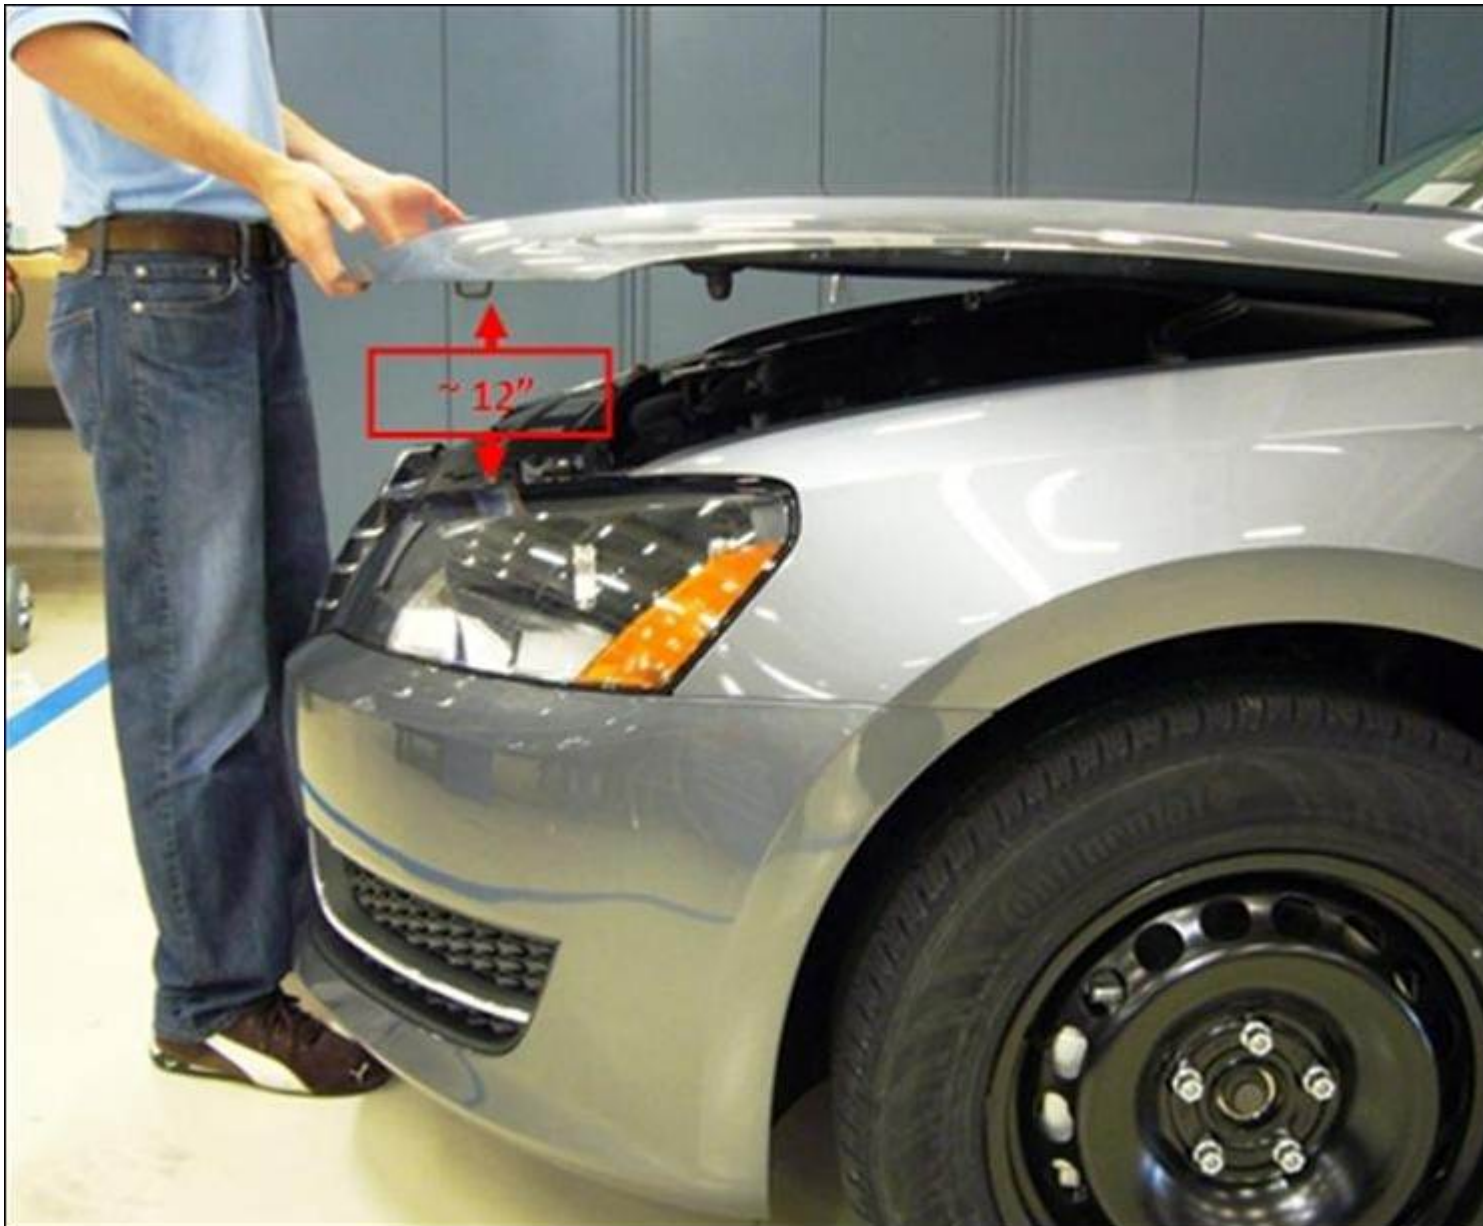
12" may be approximately waist height (assuming an average height). When closing the hood above the waist, please lower it before dropping it ensuring 12" are not exceeded.

When closing the engine hood following any service or inspection, make sure that the hood is at a distance no greater than 12 inches before allowing the hood to drop closed, as per the vehicle owner guide.
