Tech Tips

TT 94-12-02

2012 – 2013 Passat – Possible Damage to DRL Bulb Filament upon Hood Closure

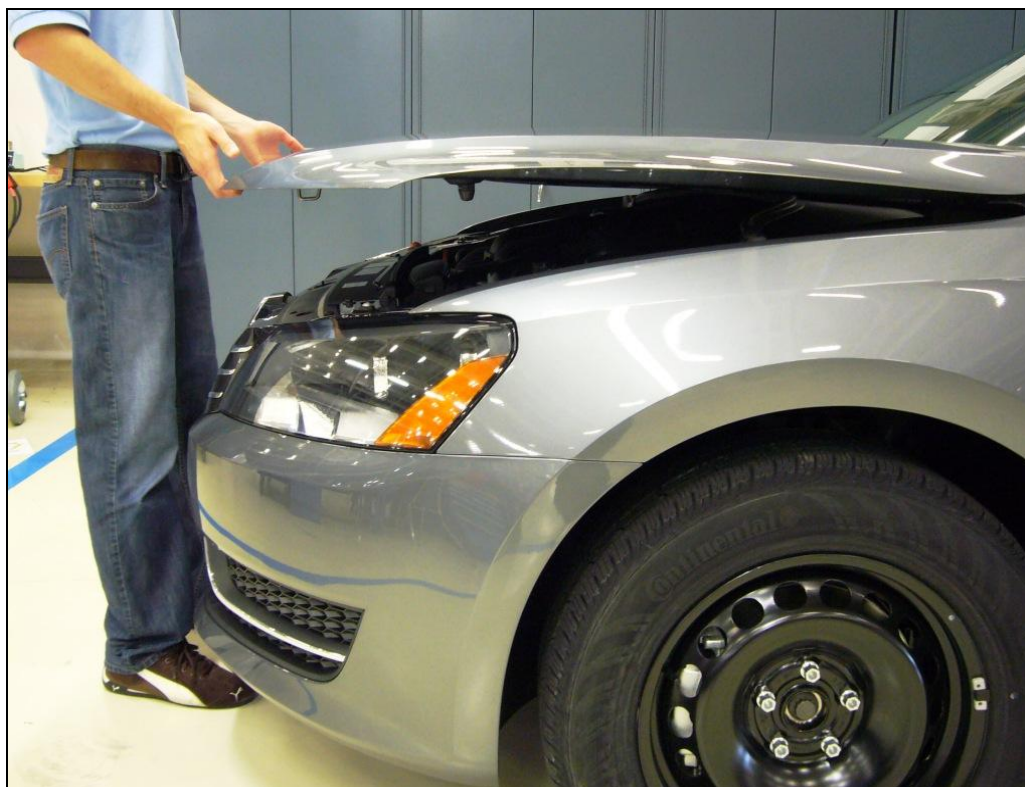
When closing the engine hood following any service or inspection, make sure that the hood is at a distance no greater than 12 inches before allowing the hood to drop closed, as per the vehicle owner guide.

Tip: 12" may be approximately waist height (assuming an average height). When closing the hood above the waist, please lower it before dropping it ensuring 12" are not exceeded.

Under certain conditions (speed, force, temperature, time) the Day Time Running Light (DRL) bulb can be subjected to premature failure. Excessive shock is generated from closing the hood caused by allowing it to drop from too great of a distance, which could result in premature failure of the DRL bulb filament.
