2011-2013 Optima  
(TF & QF)

PS235

**SUBJECT: HORN CHIRP AND PARKING LAMPS INOP WHEN  
LOCKING DOORS WITH RKE FOB**

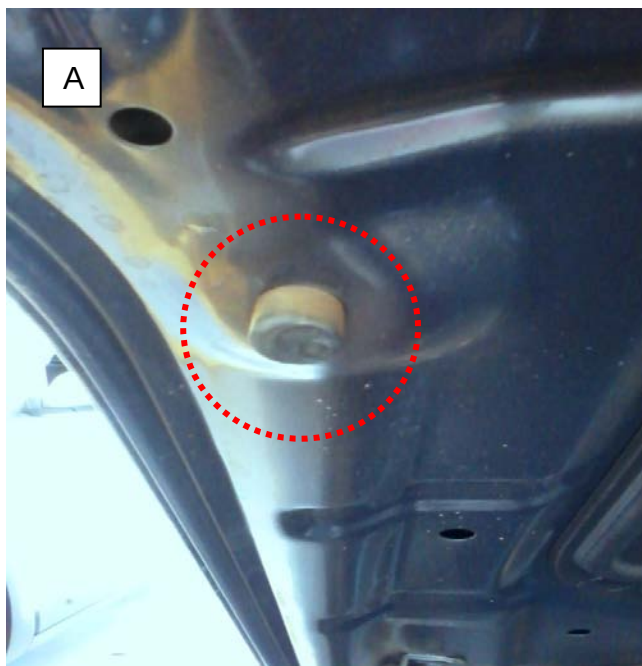
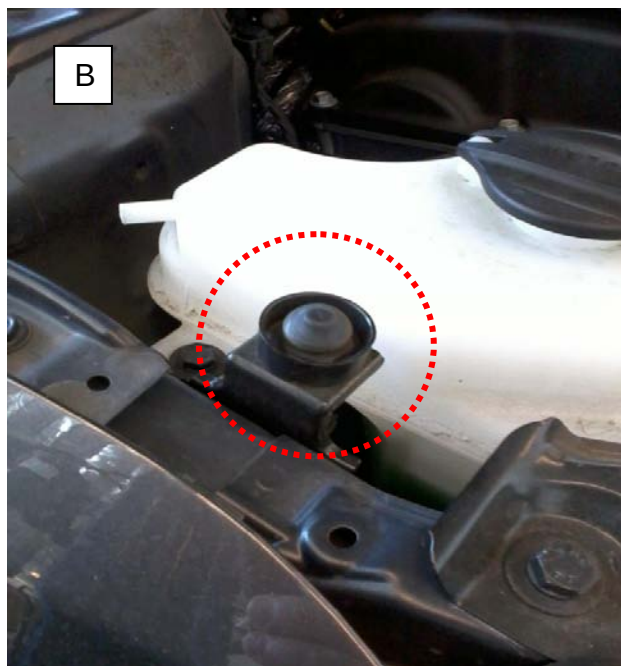
If you encounter a customer complaint relating to the vehicle not producing an audible tone, or horn chirp, and the parking lamps not flashing when locking the vehicle with the RKE fob, check to make sure the rubber hood stopper (A) is in place on the hood. The rubber stopper depresses the hood switch (B) and if not in place, may cause this condition, and may also prevent the alarm system from operating correctly.
