REFERENCE:	Nova Bus Manuals
SECTION:	09 Engine
RS N°:	MQR 7621-515
EFFECTIVE IN PROD.:	L692-46 (2012DE)

SUBJECT:	Hydraulic system
JUSTIFICATION:	Hydraulic fluid may leak from loose connections in the radiator compartment, and at the hydraulic manifold block.

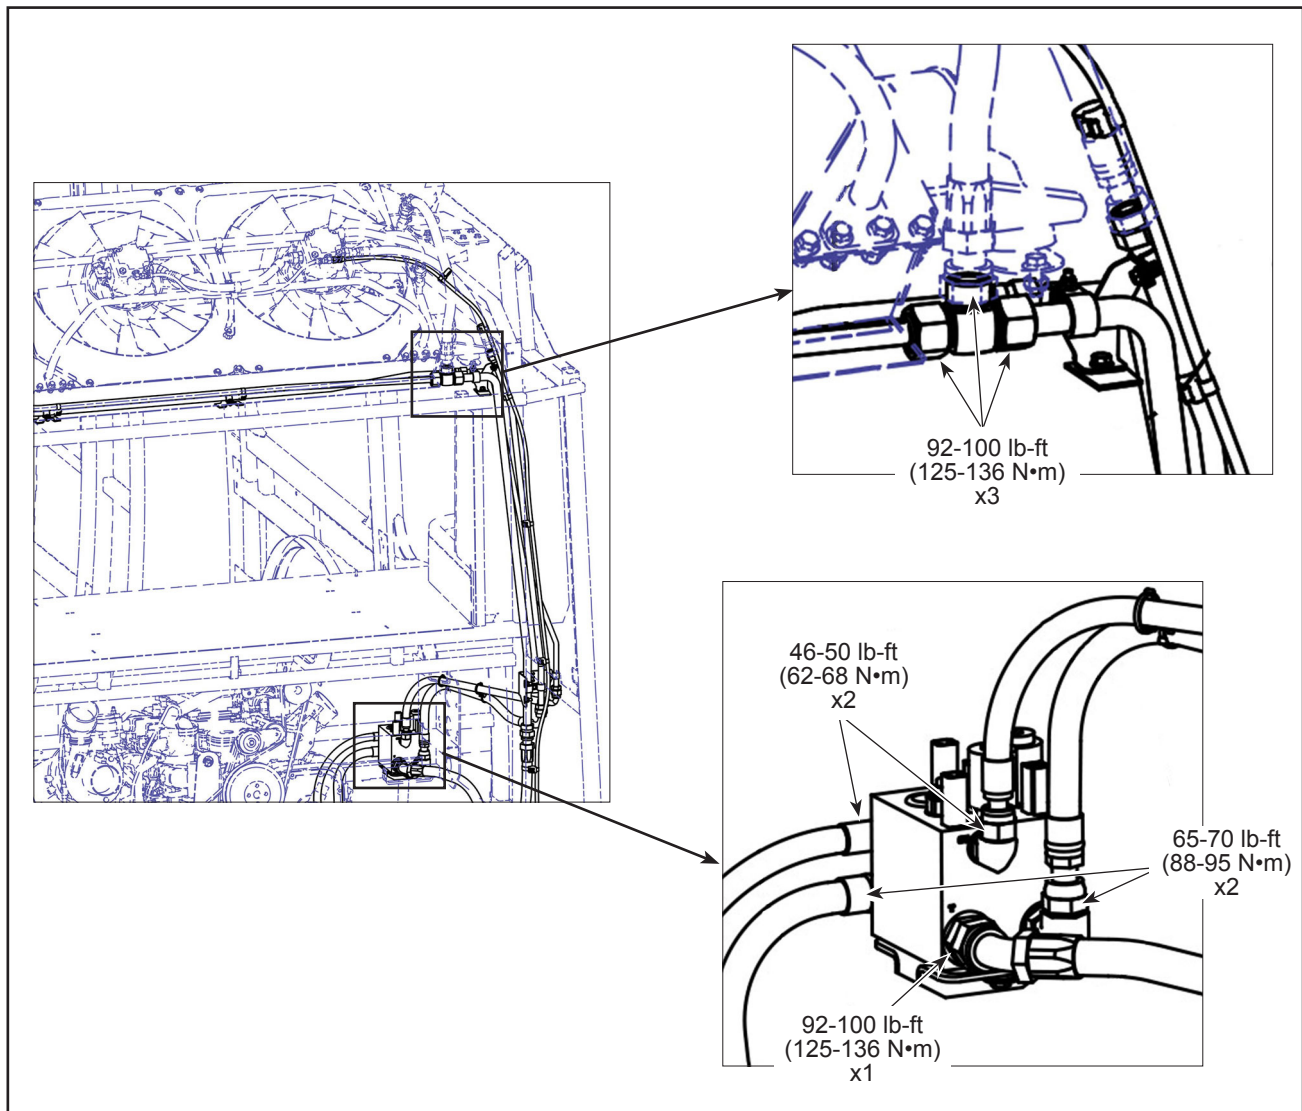
Figure 1 - Partial View of the Hydraulic System

1.1. Retighten to the torque values indicated in Figure 1. ❖

LEVEL	DESCRIPTION	DIRECT CHARGES		TIME
		LABOUR	MATERIAL	
1	Retighten the hoses to the specified torque values.	Nova Bus	Nova Bus	30 min
2	-	-	-	-
