# MIRROR SWITCH REWORK

**Property and Top Bus Number:** DART: 304500

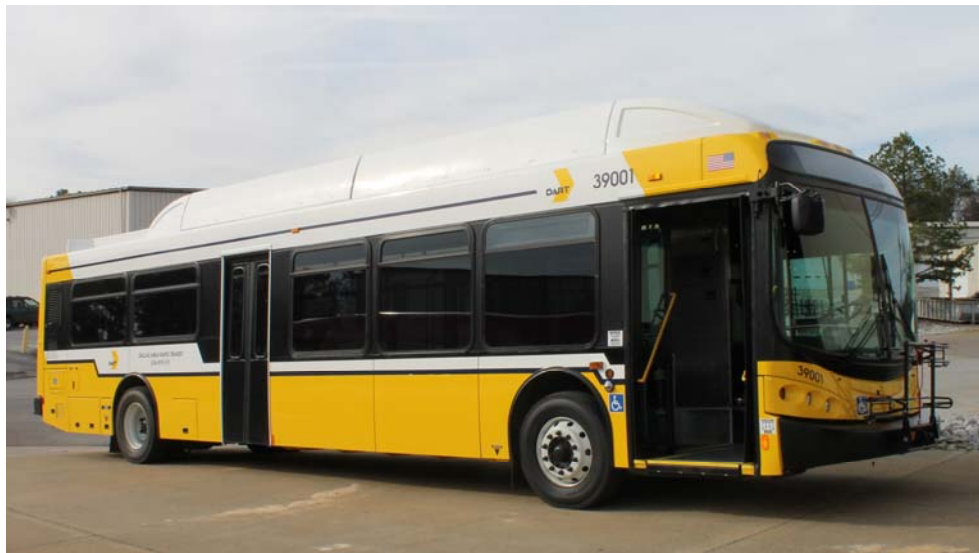
**Issue:** loose mirror switches

**Reason/ cause:** switches loose in side dash

**Solution:** add mirror switch clips

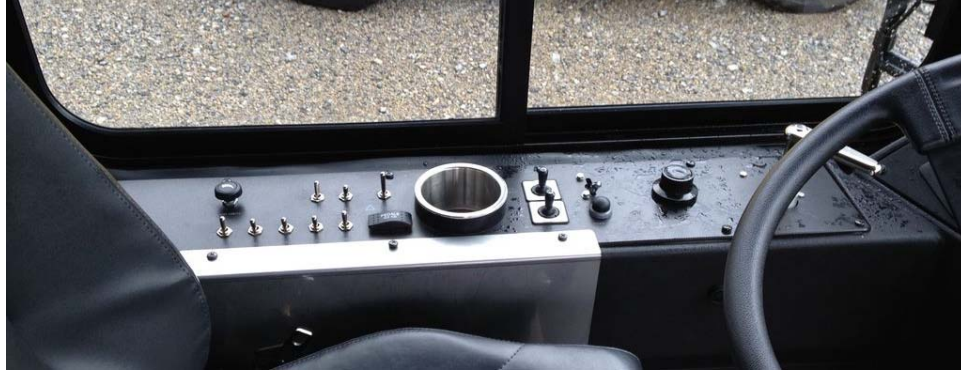
1. Park the bus and apply the parking brake.
2. Turn off main battery disconnect switch(es).
3. Remove screws around the side dash. turn side dash on its side

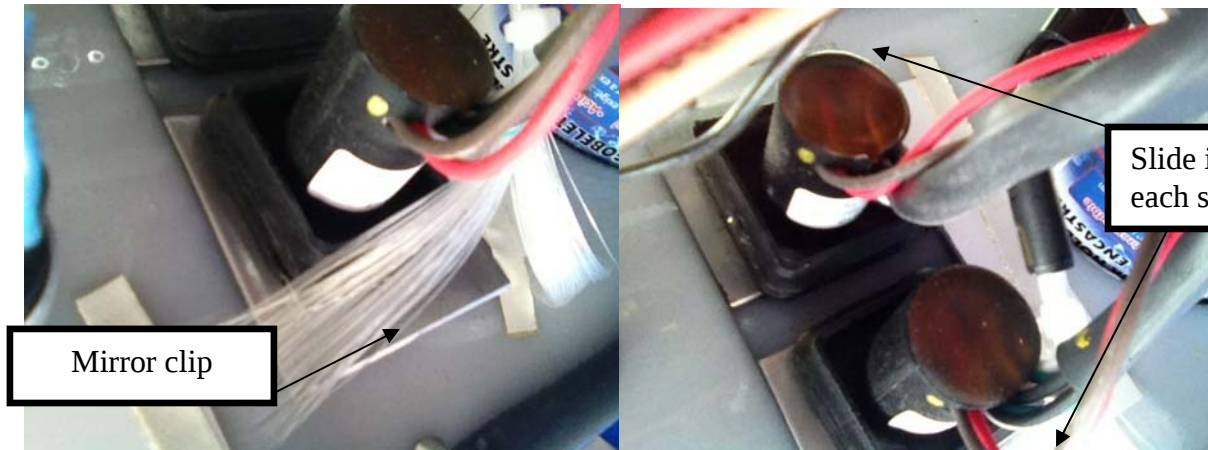
4. Slide the mirror clip in from each side
