**REAR ELECTRIC BOX WATERTIGHTNESS X3-45 VIP MTH & ENTERTAINERS REFER TO SAP FOR VEHICLES AND CODES.
SE RÉFÉRER AU RETROFIT PRODUCTION R13081 POUR LA VERSION FRANCAISE**

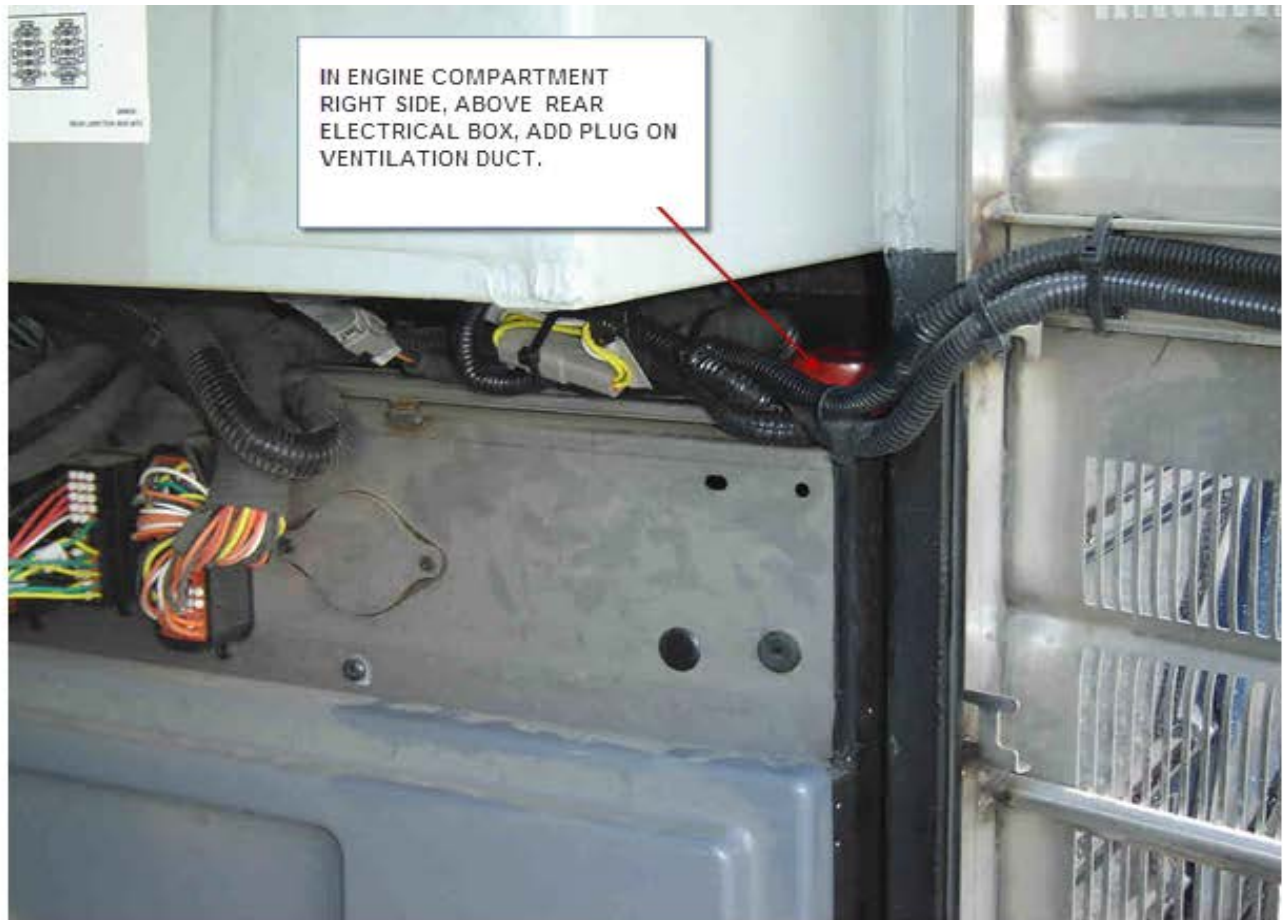
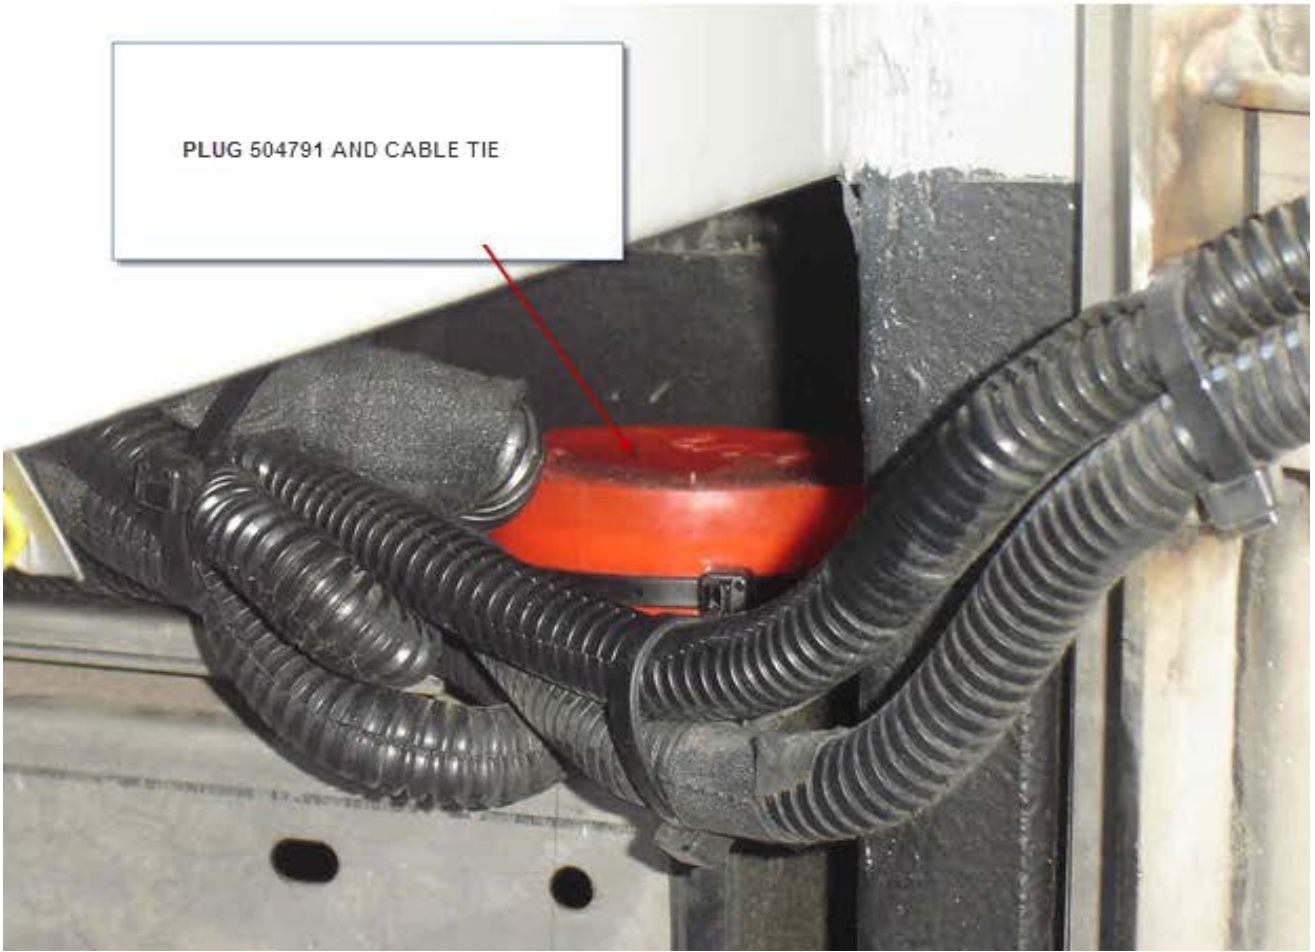
THE VENTILATION DUCT ON THE REAR ELECTRICAL BOX MAY NOT BE CLOSED PROPERLY ON X3-45 MOTORHOMES AND ENTERTAINER.

PLUG 504791 AND CABLE TIE

IN THE ENGINE COMPARTMENT RIGHT SIDE, ABOVE THE ELECTRICAL BOX, ADD A PLUG (504791) AND CABLE TIE 504016 ON THE VENTILATION DUCT.
