Service Bulletin

Subject: DTC P0300 With An Upper End Noise On The Cylinder That Is Misfiring

Models: 2014 Chevrolet Impala 2014 Chevrolet Malibu With engine RPO LKW vin code L

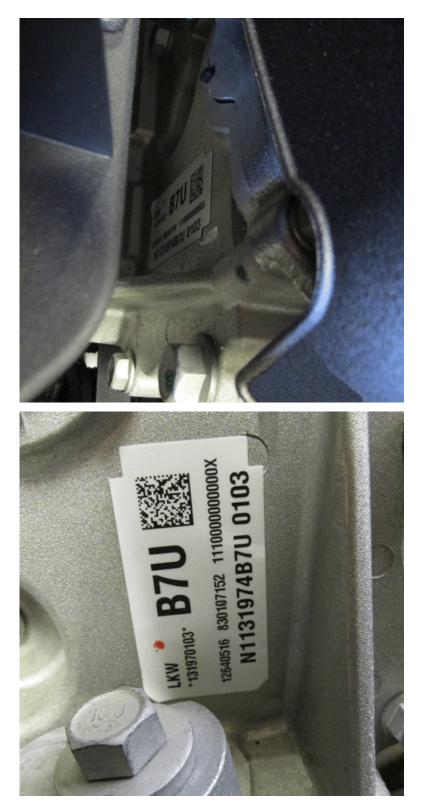
Engine Build Identification

Example: Engine Unit Identification number found on the timing cover: N1131974B7U 0103

13 = 2013

197 = 197th day of 2013 which is July 17th
