Service Bulletin

Subject: LT1 Engines May Have Been Built With An Oil Filter That Has An Incorrect Label

Models: 2014 Chevrolet Corvette
Equipped with engine RPO LT1 6.2L

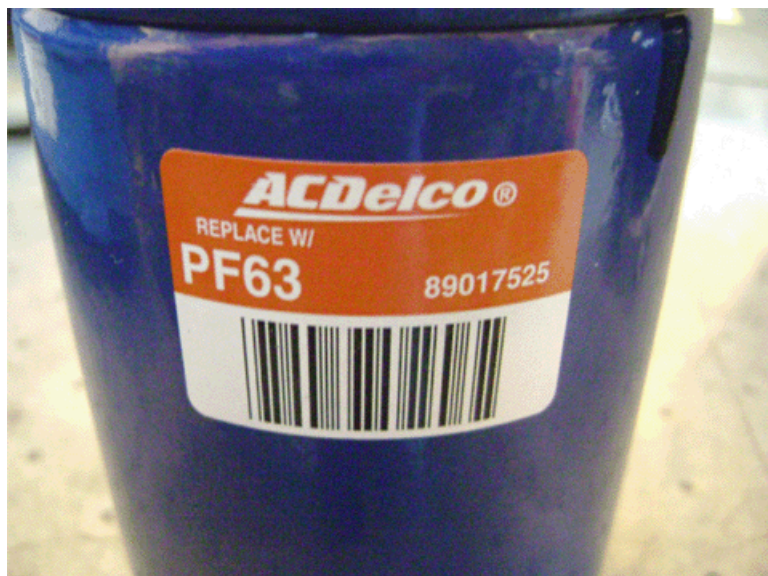
Some early LT1 engines may have been built with an oil filter that has an incorrect label on the can.

The filter is correct. However, the label is wrong.

The incorrect label says to replace the oil filter with a PF63. The correct service part is a PF64 part # 12640445.

Filter with the wrong label

Replacement of the filter for the incorrect label concern is not necessary.

The technician needs to be sure to replace the OE filter with the correct PF64 when it is time for an oil and filter change.

Caution: The PF63 will fit the engine. However, it is significantly longer and it is possible it could be damaged if the suspension goes to full compression.

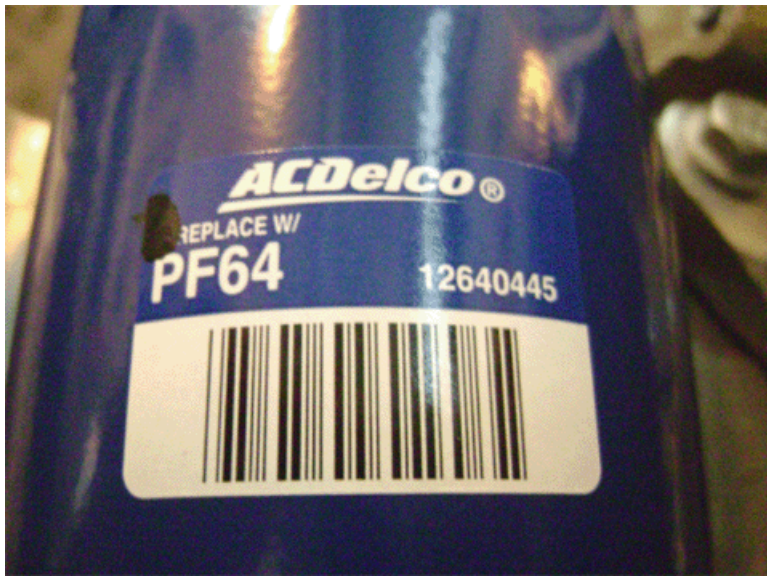
Filter with the right label
