Service Bulletin

Subject: Click Noise Heard from Front Compartment Area, Possible DTC P059F Set

Models: 2014 Chevrolet Spark EV

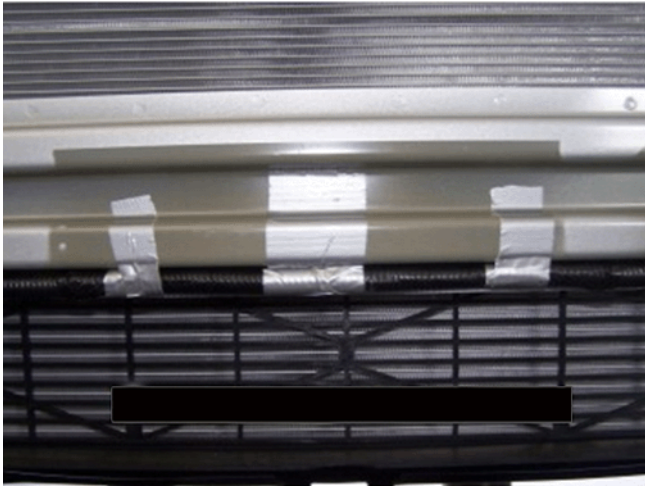
The above graphic shows a closer view of the taped harness to the support.
