REFERENCE:	Nova Bus Manuals
SECTION:	04: Front suspension 05: Rear suspension
RS N°:	MQR 7621-711
EFFECTIVE IN PROD.:	–

SUBJECT:	Brake caliper shipping cap.
JUSTIFICATION:	The shipping cap should have been removed in production.

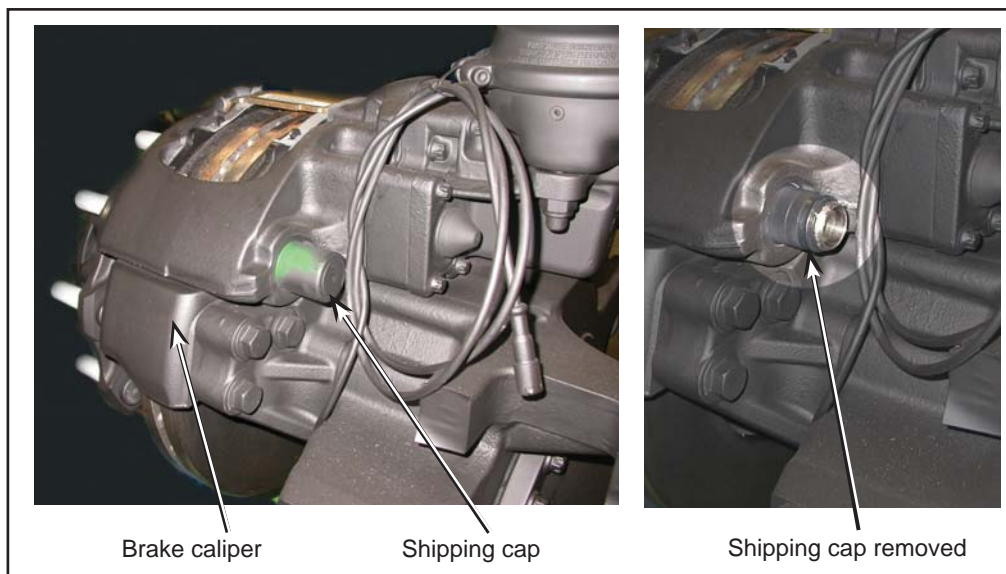
Figure 1 - Shipping Cap Location

- 1.2. Locate the six brake calipers.
- 1.3. Locate the shipping caps on each calipers. See Figure 1. The caps can be identified by their green color, but they may have been painted black.

- 1.4. Remove the six shipping caps. Discard the caps.
- 1.5. Lower the vehicle.
- 1.6. The vehicle may be returned to service. ❖
