Technical Service Bulletin

01 MIL on (P0491 and P0492 stored at same time)

01 13 37 2033001/4 October 10, 2013. Supersedes Technical Service Bulletin Group 01 number 13-24 dated August 20, 2013 for reasons listed below.

Model(s)	Year	VIN Range	Vehicle-Specific Equipment
S4	2010 - 2011	All	3.2 FSI AVS and 3.0 TFSI engines
A5	2010		
S5 Cab	2010 - 2013		
A6	2009 - 2011		
Q5	2010 - 2012		
Q7	2011 - 2012

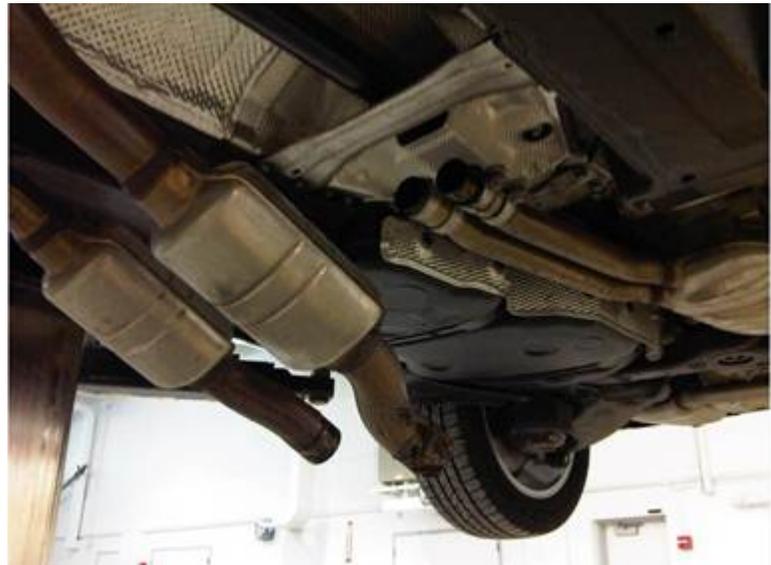
Figure 7. Lowered catalytic converter pipes

1. Move the exhaust sliding bushings (that connect the catalytic converter and muffler) back, then lower the catalytic converter pipes (Figure 7).

For Q7, unbolt muffler from catalytic converter. Cover mufflers with plastic bag to prevent water from entering.

Cleaning water will drain out of the catalytic converter pipes during the cleaning process.

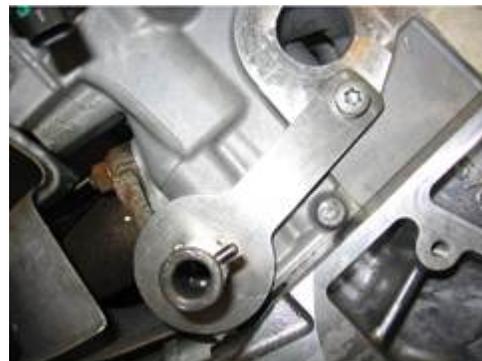
3. Install engine adaptors on the appropriate banks (Figure 13, Figure 14).

Figure 13. Engine adaptor on bank one.

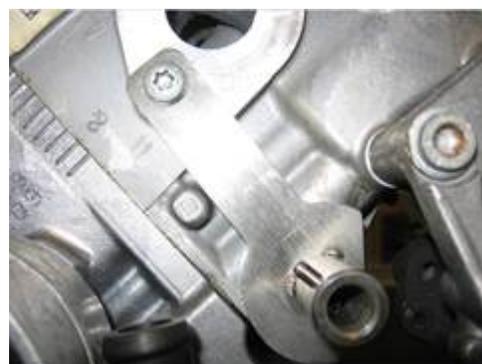
Figure 14. Engine adaptor on bank two.

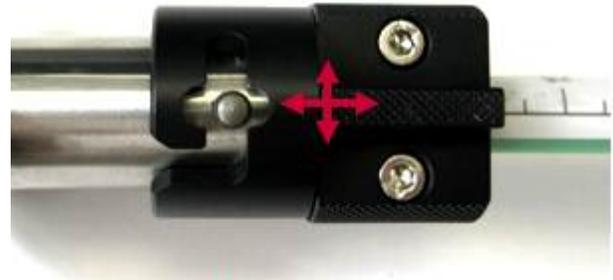
Figure 16. Locking position / transvers longitudinal movement and of the hose adaptor

- After adjusting the position of the hose adaptor, insert the special single port cleaning hose into the hose adaptor, and bring it back into locking position (Figure 16).

- While cleaning, make sure that the pressure washer is supplying pressure greater than 1800 psi.
- Based on the washer's pressure, clean the port based on the table below. While cleaning, continuously move the hose adaptor within the longitudinal and transvers slots (Figure 16).

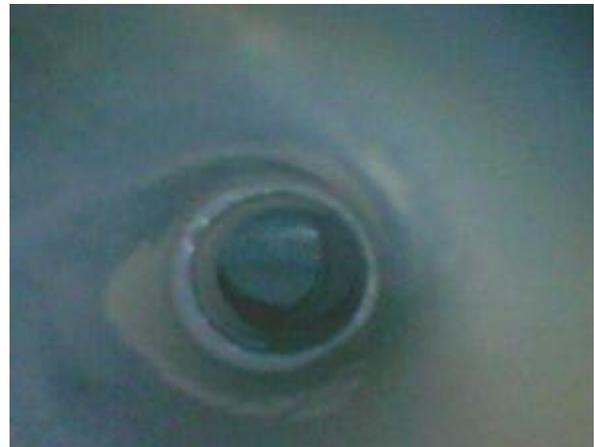
Figure 17. Clean single port.

- Do the same for all remaining cylinders.
- It is recommended that after cleaning, all single ports are checked with snap-on boroscope BK6000 (or similar, with 90-degree lens), to make sure all ports are clean (Figure 17).

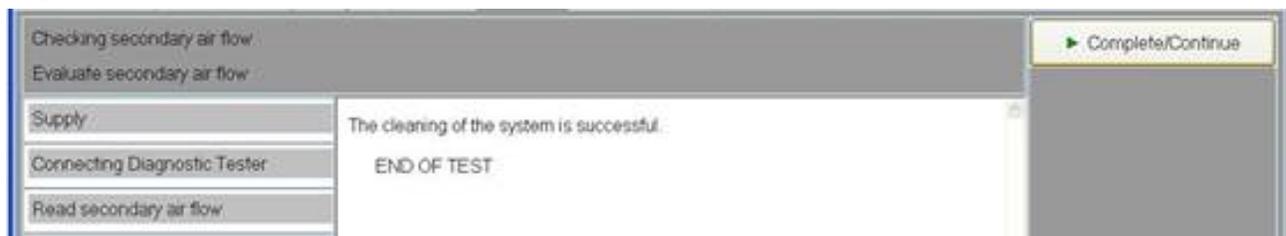
Figure 18. Successful cleaning screen.

11. Let the car run at idle for 15 minutes so all remaining water in the exhaust system can evaporate.
12. Perform ODIS testing again. Follow steps 2 - 8 of the *Perform ODIS Testing* section of this bulletin. If cleaning was successful, numbers for both banks will be above 0.7, and the screen below will be displayed (Figure 18).
