# Technical Service Bulletin

## 01 MIL on (DTC P0456 or DTC P0442 (EVAP emission control system leak detected))

01 13 38 2035519/1 October 23, 2013.

Model(s)	Year	VIN Range	Vehicle-Specific Equipment
Q7	2013 - 2014	All	Not Applicable

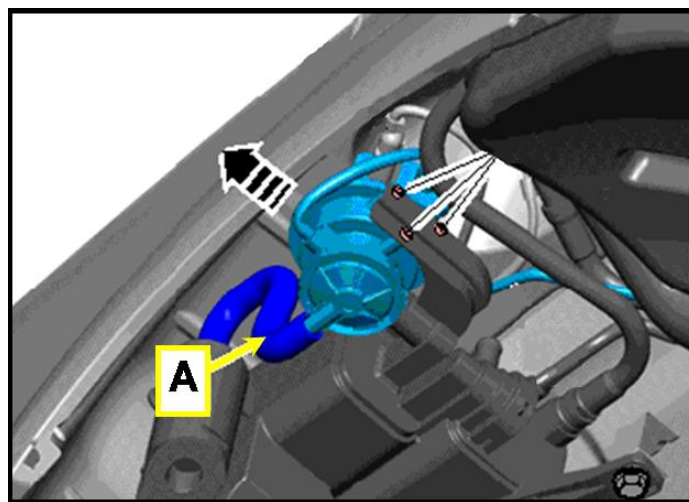
Figure 1. Hose leading to LDP air filter (A).

1. Visually inspect the EVAP system for any loose connections or damaged parts. If found, repair the loose connections and/or replace the damaged parts.
2. Pressurize the EVAP system using the KLI9210 Smoke/Pressure test:
  - Clamp off the hose that leads to the LDP air filter (Figure 1). Use hose clamps up to 25 mm diameter (Figure 2).
  - Pressurize the EVAP system to 12 inch/water (30mbar), and check pressure loss over time.

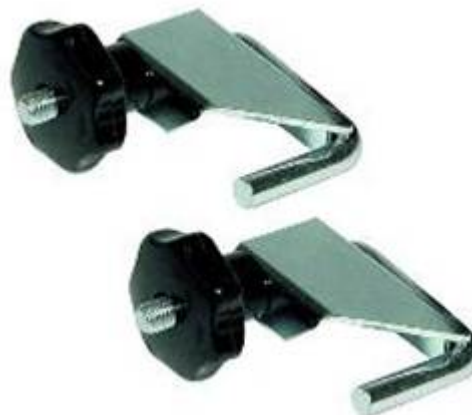
Figure 2. Tool -3094-, hose clamps.
