## 46 Brake pulsation/thumping - Repair Authorization

46 13 59 2035506/1 October 7, 2013.

Model(s)	Year	VIN Range	Vehicle-Specific Equipment
A6, A7	2014	All	3.0T

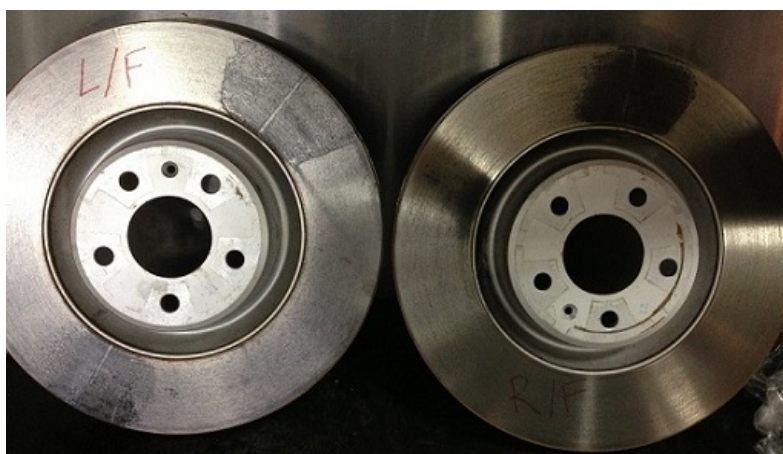
- Any of the following conditions are found on a low-mileage MY14 A6 or A7:
  - Customer or technician hears a thumping noise while braking.
  - Customer or technician feels pulsations while braking.
  - There is brake pad residue (also called “pad marks”) on the brake discs (Figure 1).

*Figure 1. Example of brake discs with brake pad residue.*

1. Verify that at least one of the conditions listed in the *Condition* section exists.
2. If the vehicle is within the New Vehicle Limited Warranty, contact a TAC consultant before proceeding.
3. Please attach pictures of the condition to the TAC ticket before calling TAC.
