Technical Service Bulletin

91 Bluetooth call quality poor / VR commands not recognized

91 13 03 2034842/2 September 6, 2013. Supersedes Technical Service Bulletin Group 91 number 13-94 dated July 24, 2013 for reasons listed below.

Model(s)	Year	VIN Range	Vehicle-Specific Equipment
A6/A7	2012-2014	All	All

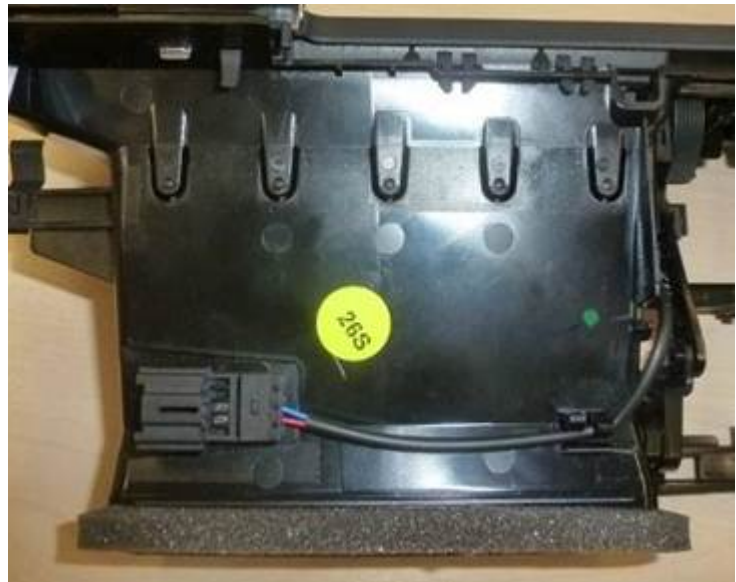
Figure 1. Part version sticker on top of center air vent.

1. With the customer, determine if the issue is occurring when the climate control is set to a higher fan speed and if the center air vents are primarily pointed upward when this occurs.
 - If the center air vents are not pointed upward, or if the issue occurs when the defroster is in use, this section does not apply. Please inform the customer that strong air circulation from the defroster will affect the performance of the microphones.
 - If the center air vents are pointed upward when the issue occurs, proceed with **Section A**.
2. Remove the center air vents and inspect for a sticker on top of the vents (Figure 1).
 - If the sticker is not present, or if the sticker is below version **26S**, replace the vents.
 - If the part is already at version **26S**, do not replace the vents.
