Technical Bulletin

20 13 06 July 18, 2013 2034072

Activated Charcoal Filter System, Solenoid Valve 1 -N80- (Canister Purge Valve) Diagnosis

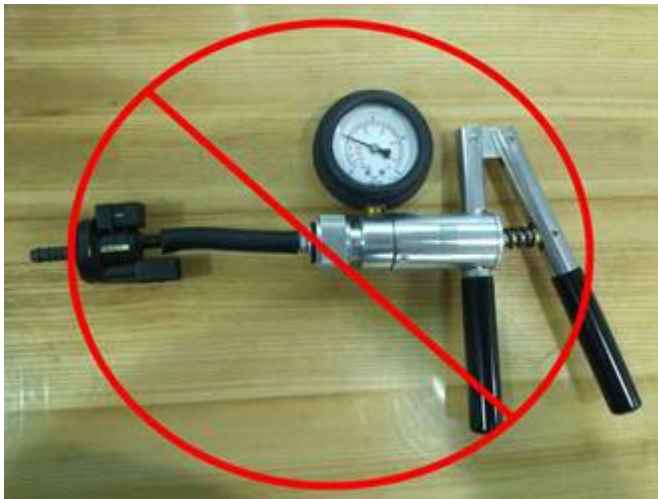
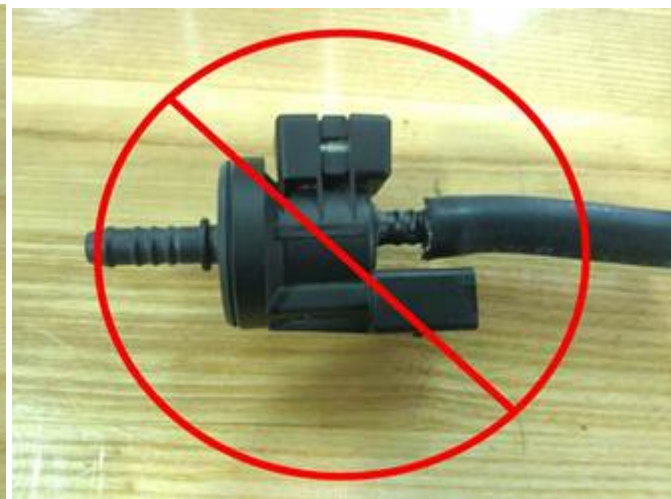
- Incorrect Installation of VAS6213 vacuum pump on the Canister Purge Valve (N80). This will create a false leak resulting in unnecessary replacement. (Bosch valve shown below)

When performing a vacuum check on the canister purge valve please ensure to hook the vacuum pump up correctly for the valve (Vacuum should be applied to the side the flow indicator is pointing). If the vacuum pump is installed incorrectly, the seal will be pulled open, causing a false leak.

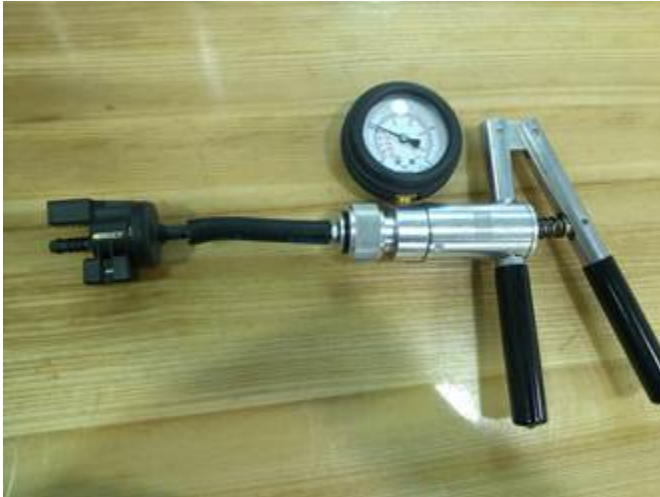
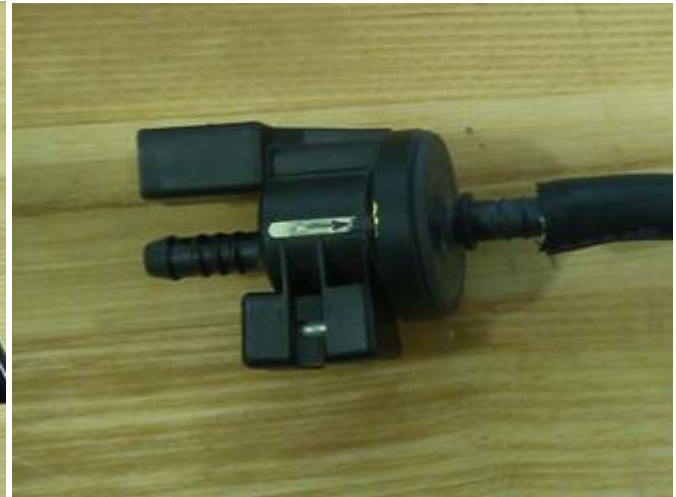
- Correct installation of VAS6213 vacuum pump on the Canister Purge Valve (N80). (Bosch valve shown below)

- If the valve holds vacuum, ***do not*** replace -N80- Activated charcoal filter system, solenoid valve. The canister purge valve is not causing the fault codes to store. This bulletin does not apply. Continue Guided Fault Finding based diagnosis for faults.
- If the valve does not hold vacuum, replace -N80- Activated charcoal filter system, solenoid valve. Perform leakage test to verify there are no further issues.
- Clear any DTCs that were caused by disconnecting the canister purge valve electrical connector during the test.

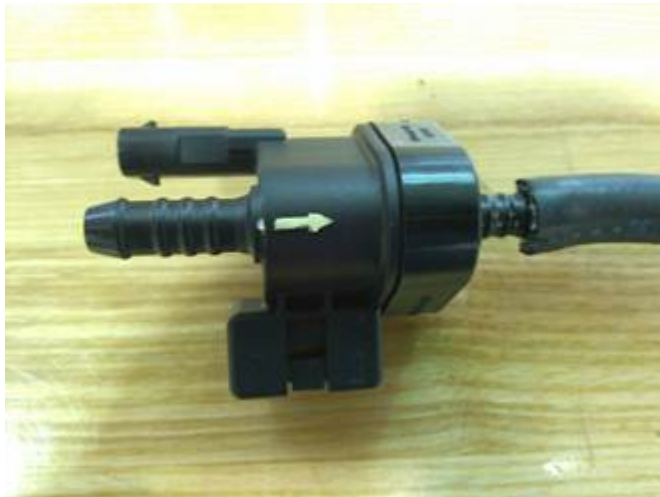
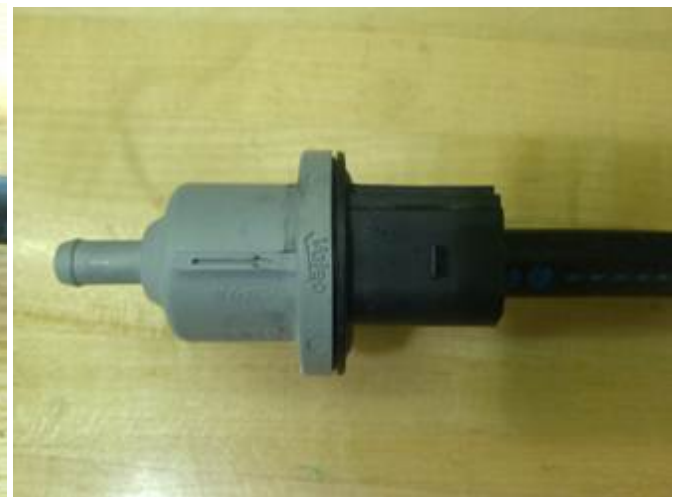
- Correct installation of VAS6213 vacuum pump on the Canister Purge Valve (N80). (Freudenberg and Valeo valves shown below)

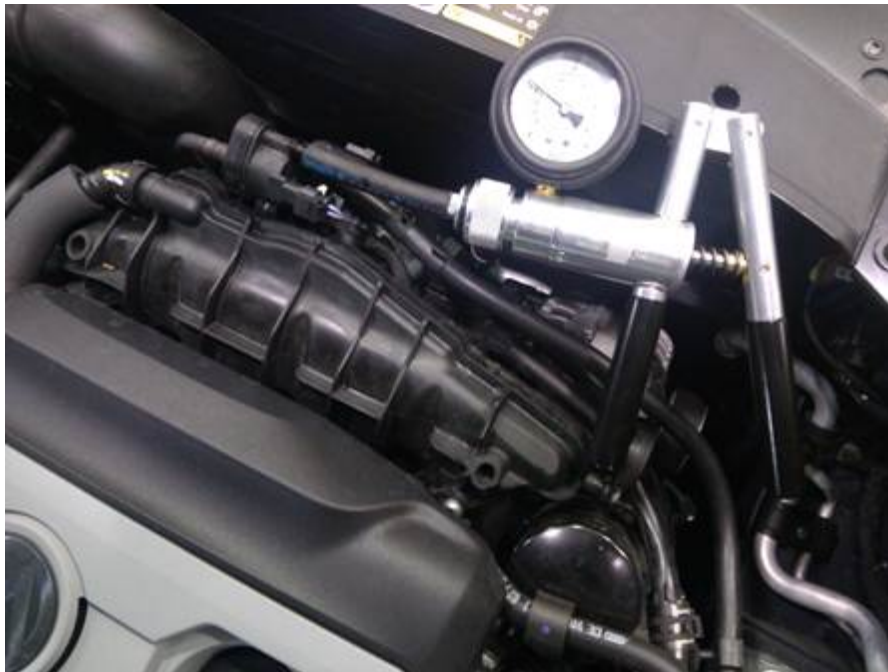
- With the engine off, remove rubber hose from EVAP Canister side of N80 Canister Purge Valve.
- Install VAS6213 vacuum pump to the N80 purge valve as shown below.

- Disconnect the electrical connector from the purge valve.
- Start the engine and allow it to idle.
- Monitor the reading on the vacuum gauge. The reading should be at 0 PSI or higher (no vacuum should be measured).
- If there is no vacuum present at the vacuum gauge, **do not** replace -N80- Activated charcoal filter system, solenoid valve. The canister purge valve is not leaking and is not causing the fault codes to store. This bulletin does not apply. Continue Guided Fault Finding based diagnosis.
- If vacuum is present, replace -N80- Activated charcoal filter system, solenoid valve. Perform leakage test to verify there are no further issues.
- Clear any DTCs that were caused by disconnecting the canister purge valve electrical connector during the test.

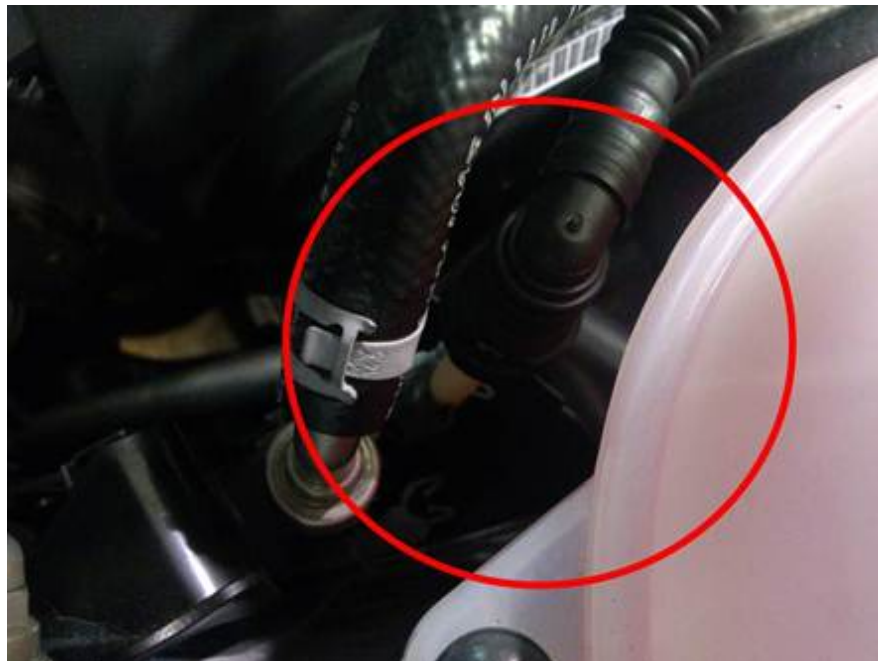
- With engine off, disconnect EVAP line connection to -N80- purge valve beneath coolant expansion tank shown below.

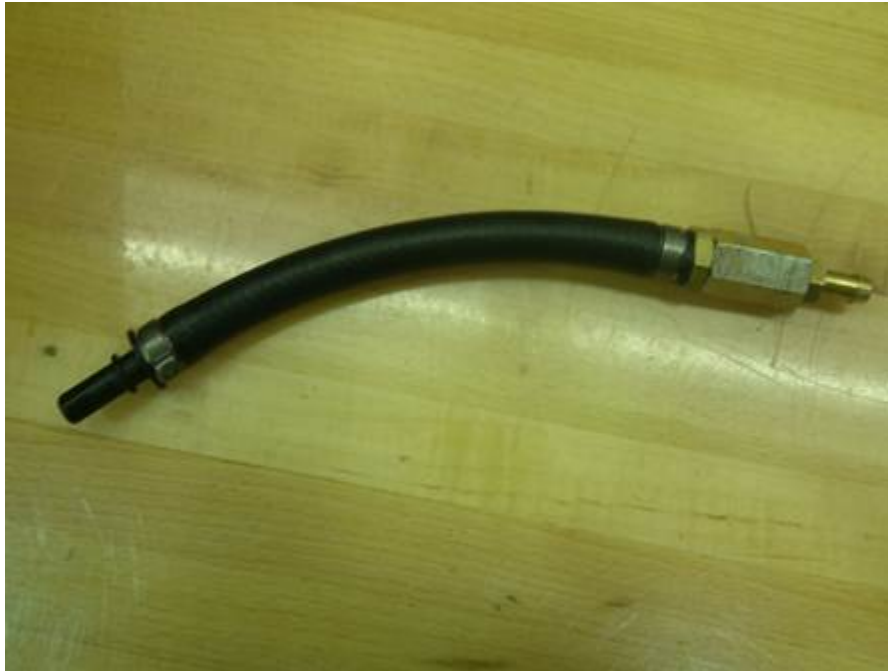
- Use the VAG1318 pressure gauge kit to assemble an adaptor using tool numbers VAG1318/24, VAG1318/11, and the female to female adaptor for the pressure gauge as shown below.

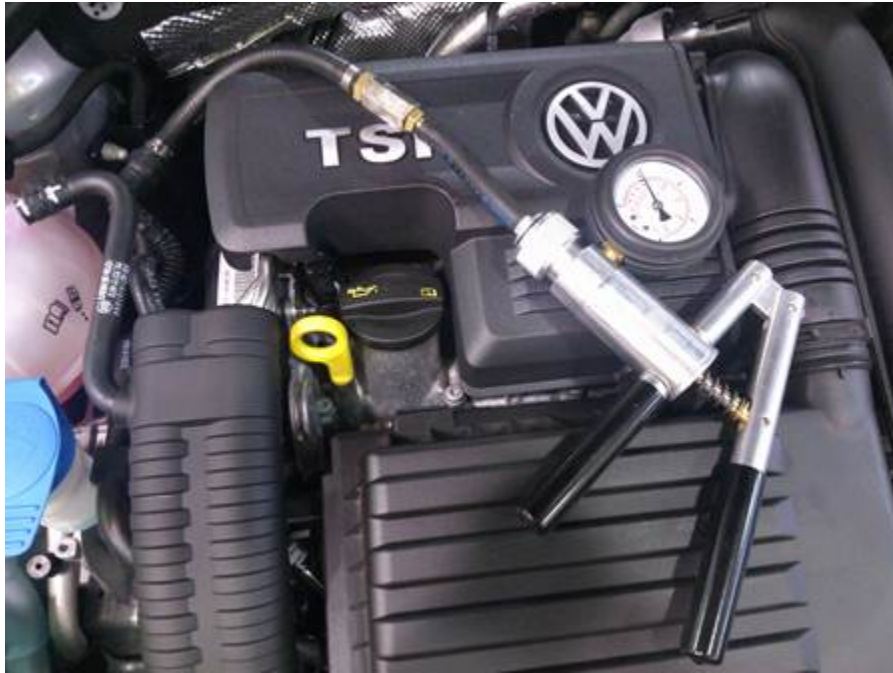
- Install the adaptor to the EVAP line connection to the -N80- purge valve and connect VAS6213 vacuum pump to the adaptor as shown below.

- Disconnect the electrical connector from the purge valve.
- Start the engine and allow it to idle.
- Monitor the reading on the vacuum gauge. The reading should be at 0 PSI or higher (no vacuum should be measured).
- If there is no vacuum present at the vacuum gauge, **do not** replace -N80- Activated charcoal filter system, solenoid valve. The canister purge valve is not leaking and is not causing the fault codes to store. This bulletin does not apply. Continue Guided Fault Finding based diagnosis.
- If vacuum is present, replace -N80- Activated charcoal filter system, solenoid valve. Perform leakage test to verify there are no further issues.
- Clear any DTCs that were caused by disconnecting the canister purge valve electrical connector during the test.
