**Document ID:** IK1200992  
**Revision:** 0  
**Created:** 10/22/2013  
**Last Modified:** 10/27/2013  
**Author:** Bob Ford

**Title:** RE Model Hydraulic Reservoir Fluid Sight Tube

**Applies To:** RE Model School and Commercial Bus, PB30500, PC30500

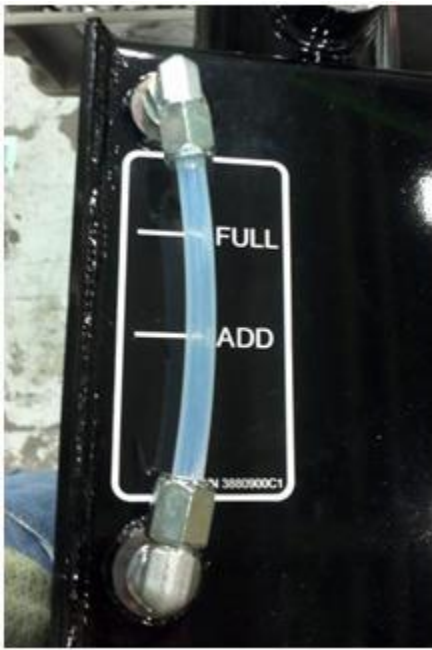
Sight tube leaks need to be repaired based on condition found during inspection. Verify fitting, fitting ferrule, tube insert and tube are not damaged and replaced as required. Verify tube length is 130mm (Approximately 5 1/8" long). Final installation of the fitting and tube assembly will result in the fittings slightly angled. During assembly, ensure tube is fully seated in the fitting prior to tightening sequence. Tighten nut by installing finger tight and then wrench tighten 1-3/4 to 2 turns to preset ferrule.

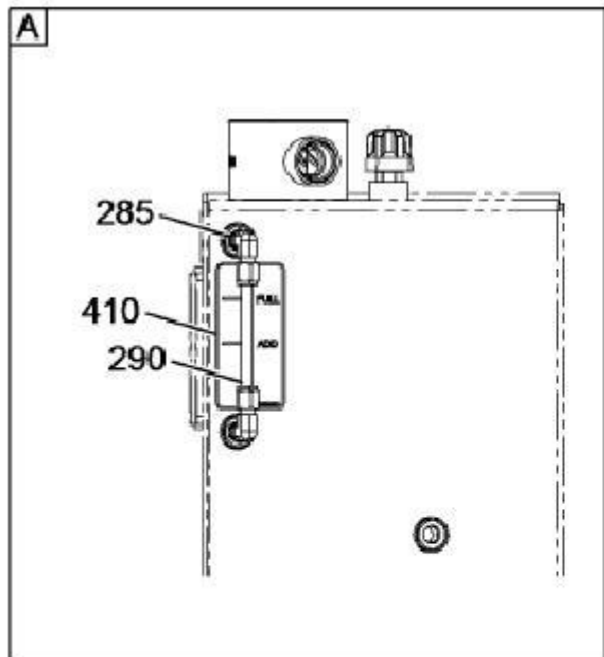
## PARTS INFORMATION

| Item | Part Number | Description |
|---|---|---|
| 285 | 3880893C1 | ADAPTER -06 ORB X 3/8 TUBE 90 |
| 285 | 3880894C1 | TUBE INSERT 3/8 |
| 290 | 3809065R1 | TUBING CLEAR 3/8" |
| 410 | 3880900C1 | PRODUCT GRAPHIC,LABEL OIL LEVEL |
