Title: Horn Sounds On Its Own While Vehicle Parked

Applies To: Trucks and busses using one of these horn pad assemblies: 3616382C1 or 3586911C1 or 3862892C1. Affected vehicles have a build date: Between March 3, 2010 - February 13, 2012 Between August 1, 2013 - December 10, 2013

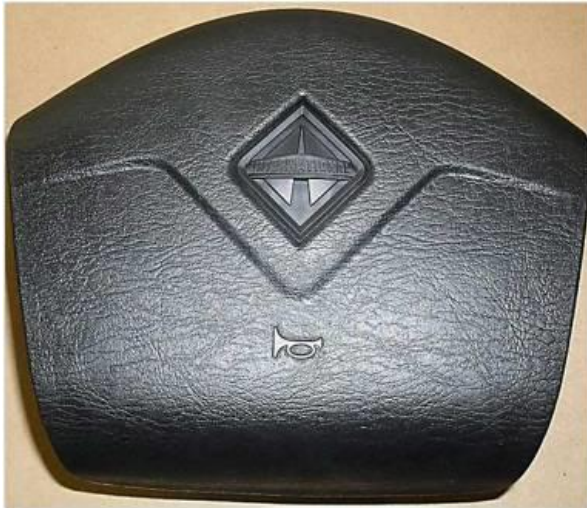
Top View

Likely cause: Horn pad assembly contains a manufacturing defect, in which the metal contact plates are bent.

Horn pad assembly

Replace horn pad assembly with known good part.
