**Document ID:** IK0900094

**Title:** Preventative Maintenance on Horton Stratis Fan Hub Anti Rotation Bracket

**Applies To:** ProStars, LoneStars, Workstar

Horton VMaster Ultra (Stratis) Viscous Fan Drive Troubleshooting Guide  
Engine feature code 12THX

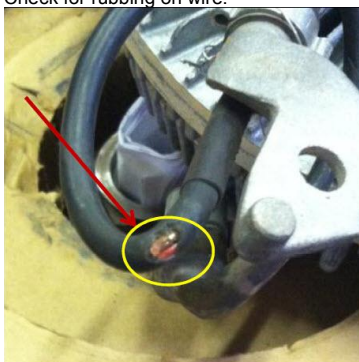
- Check for rubbing on wire.

- - If rubbing is present and inside wires are visible, but no copper is visible apply heat shrink over the harness.
  - If copper can be seen, check to see if it is only one single wire, or multiple wires.
    - If it is one wire, place electrical tape over the wire.
    - Using 4:1 heat shrink will allow the heat shrink tubing to pass over the connector as shown. P/N: ZBJE849565 or equivalent

- - If multiple wires are showing copper, remove and replace the fan hub assembly.
  - Reroute the wiring harness at outlined in the "Harness Re-Route Procedure" in this iKNow article.

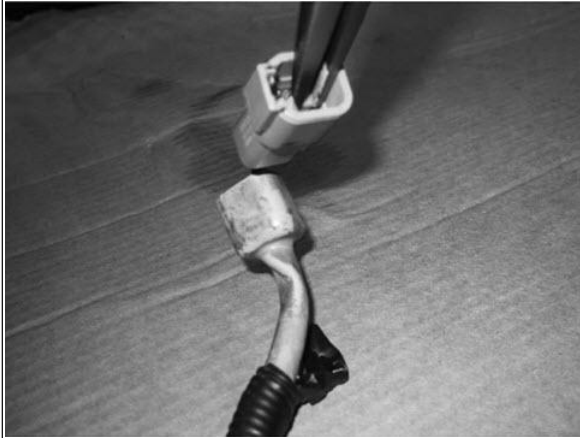
**Figure 2. Primary Lock**

9. Using needle nose pliers, remove primary lock from fan clutch harness connector (Figure 2).
