# Rear Suspension Clunk Noise

YEAR(S)	MODEL(S)	ADDITIONAL INFORMATION
2006 – 2012	RAV4

Some 2006 – 2012 model year RAV4 vehicles may exhibit a clunking noise coming from the rear of the vehicle. Upon inspection, one or both of the rear stabilizer links may be damaged. Follow the repair in this bulletin to address this condition.

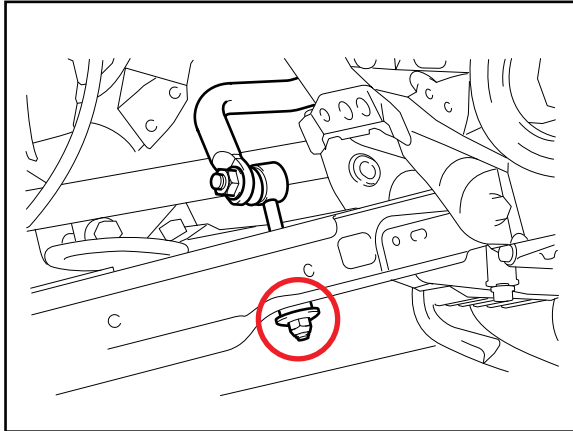
**Figure 1. Stabilizer Link Present**

1. Place the vehicle on a lift and check for presence of the Stabilizer Link under the rear suspension arm No. 2.
