# Installation of Rubber Body Plugs During PDS

USA

Avalon - Avalon HV

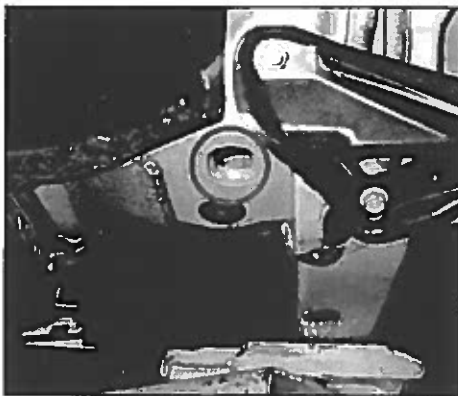
2013 Avalon vehicles are equipped with 2 front and 2 rear torque box holes located in the lower section of the body.

Figure 1. Front Tie-Down Location - Before Installation

The oval-shaped rubber body plugs should be installed in the 4 torque box holes during Pre-Delivery Service (PDS).

Installation of the rubber body plugs reduces cabin noise and prevents moisture from entering the body.

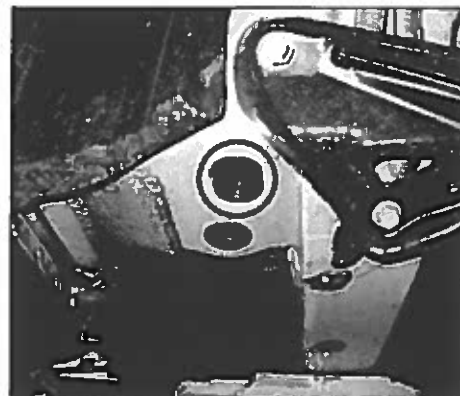
Figure 2. Front Tie-Down Location - After Installation

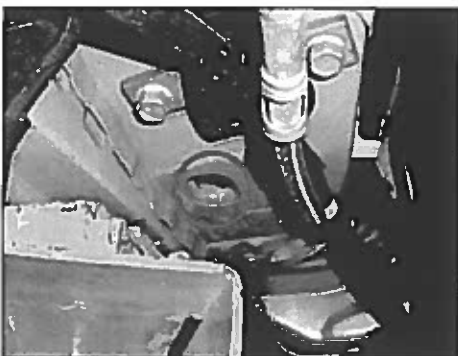
Figure 3. Rear Tie-Down Location - Before Installation

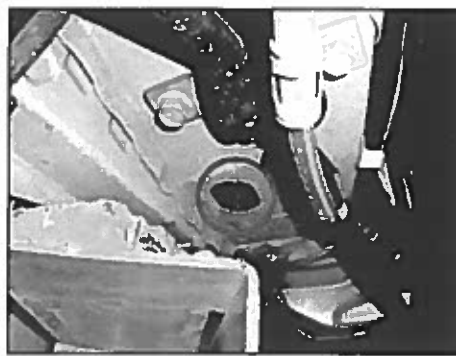
Figure 4. Rear Tie-Down Location - After Installation
