# Navigation Micro SD Card Error

Audio/Visual/Telematics

2014 IS Models with Navigation

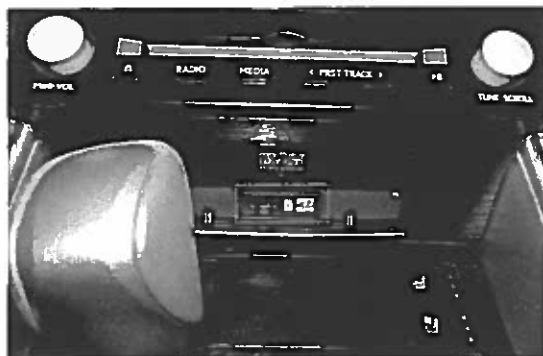
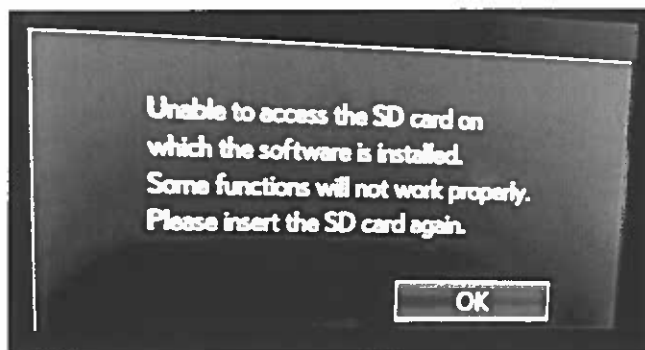
SD card reads an error when swapped from another vehicle.

- Do not interchange SD cards. SD card is "paired" with head unit.
- Once an SD card is paired with a vehicle, it may not be swapped into a different vehicle.
- A new SD card is "unpaired" and becomes "paired" when inserted into a vehicle.
- If an SD card is swapped, returning it to the original vehicle will remedy the problem.
