Service Bulletin

Subject: Front Grille Mounted Z71 Emblem Loose or Missing

Models: 2014 Chevrolet Silverado 1500 with RPO Z71
Built Prior to September 12, 2013

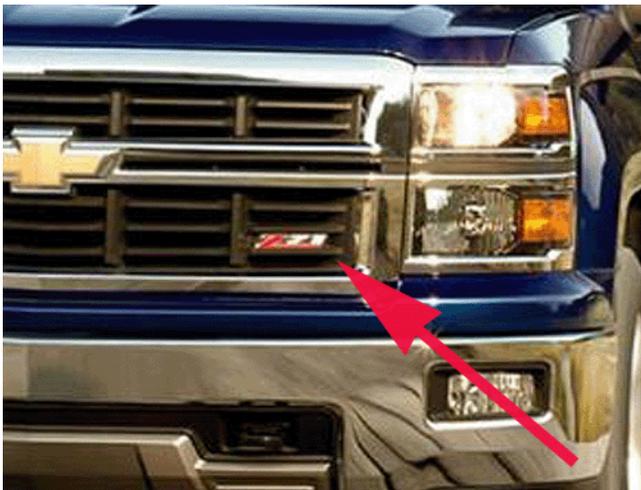
Some customers may comment that the front grille mounted Z71 emblem is loose or missing.

This condition may be caused by a failure of the adhesive tape used to attach the emblem to the grille.

Use the following steps to install a replacement emblem that has revised adhesive material:

1. Remove the loose emblem and adhesive residue if necessary. Clean the grille surface using an isopropyl alcohol and water solution (50/50) or *3M General Purpose Adhesive Cleaner, 3M P/N 08987 or Acrysol Body Solvent (Kent Auto), or equivalent, to ensure that the surface is free of contaminants such as dust, oils, wax, moisture, etc.

2. Warm the mounting surface of the grille using a heat gun. Hold the heat gun, J-25070, 152♦mm (6.0♦in) from the surface to warm the grille to approximately 70°F (21°C). Use care. If overheating occurs, the grille finish may be damaged.
Important: Failure to use promoter may reduce the adhesion properties of the mounting tape.

3. Wipe the emblem mounting area with *3M Automotive Adhesion Promoter, 3M P/N 06396.
4. Once the surface of the grille has been prepped, warm the emblem, hold the heat gun 152♦mm (6.0♦in) from the emblem and heat the front and back of the emblem using a circular motion for 30 seconds, making the emblem pliable.
Important: Do not touch the adhesive of the emblem.

5. Remove the backing film from the emblem.
6. Immediately locate the emblem to the correct position on the grille.
7. Using a roller, apply pressure evenly along the entire surface of the emblem to ensure proper adhesion.

8. Inspect the emblem for gaps and bonding.
