Bulletin No.: PI0341B

Service Bulletin

Subject: Front Sunroof Sunshade Will Not Latch in Closed Position

Models: 2010-2011 Buick Enclave

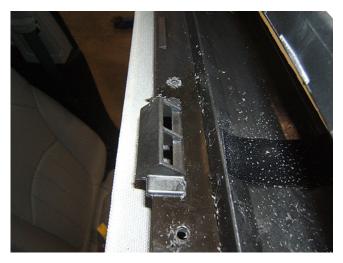
The molded-in sunroof sunshade striker on the sunroof module may be broken.

- 1. Check that the sunroof sunshade striker fits into where the broken striker was by placing the sunroof sunshade striker under the bottom of the front rail. File to fit if necessary.
- 2. Place the sunroof sunshade striker on the top surface of the front rail to locate the holes.
