Service Bulletin

Subject: Supplemental Repair Required for Drive Motor Battery Coolant Radiator Replacement Due to Stone/Foreign Material Impact

Models: 2011-2013 Chevrolet Volt

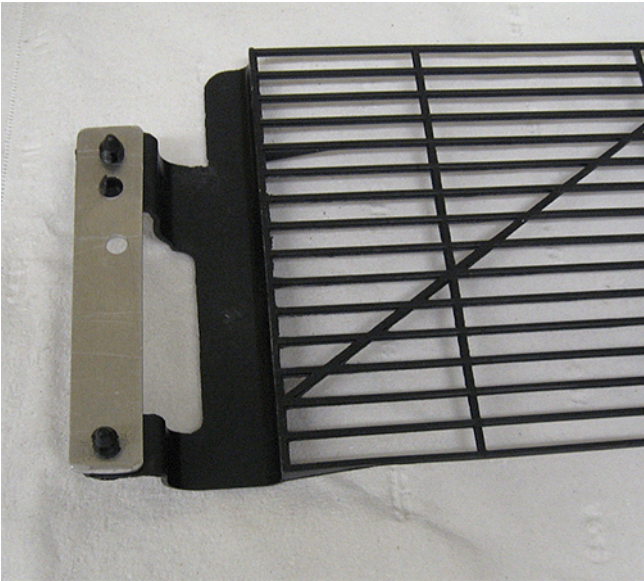
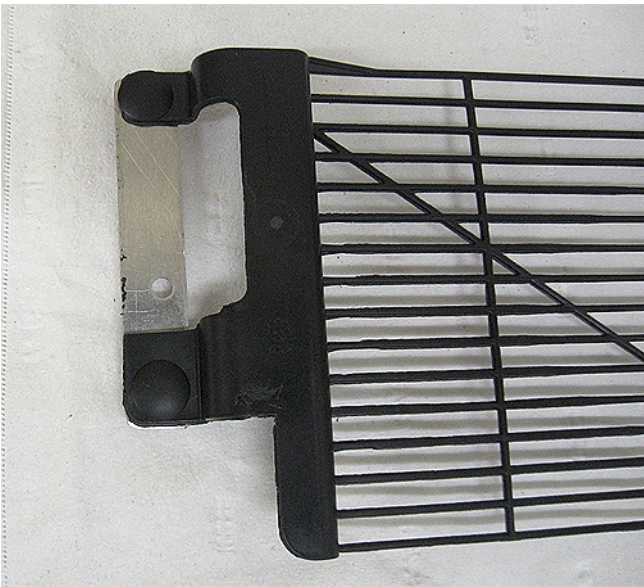
1. Remove the damaged drive motor battery coolant radiator. Refer to the Drive Motor Battery Coolant Radiator Replacement procedure in SI.
2. Replace or transfer the existing radiator grille screen to the new radiator.
3. Fabricate two mounting brackets for the additional screen using 25 mm (1 in) x 114 mm (4.5 in) aluminum stock with thickness between 1.59 mm (0.0625 (1/16) in) and 3.18 mm (0.1250 (1/8) in). This material can be obtained locally. A good source for this material is Home Depot. The Home Depot carries Everbilt 1 in. x 36 in. Aluminum Flat Bar with 1/8 in. thickness, Model #44690 (Home Depot Canada carries H. Paulin - Model #142-642).
4. Remove any burrs on the cut surface(s) and round the corners using a file.

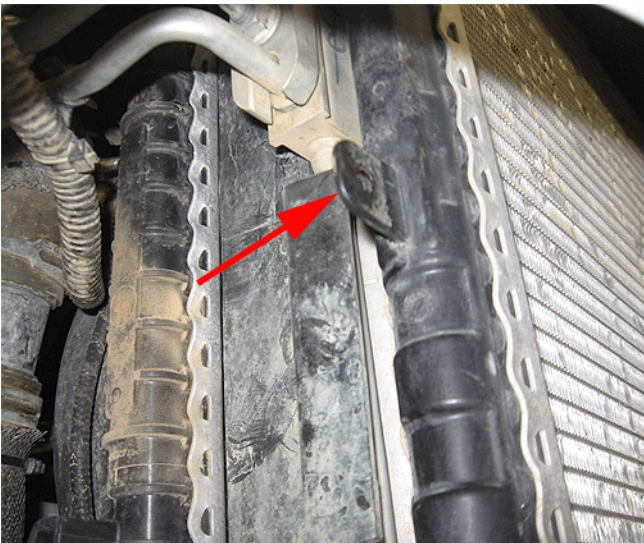
5. Using the grille screen mounting tabs as the template, drill holes as shown using a 6.25 mm (0.250 in) drill bit.
6. Mount the brackets to the screen using the retainers.

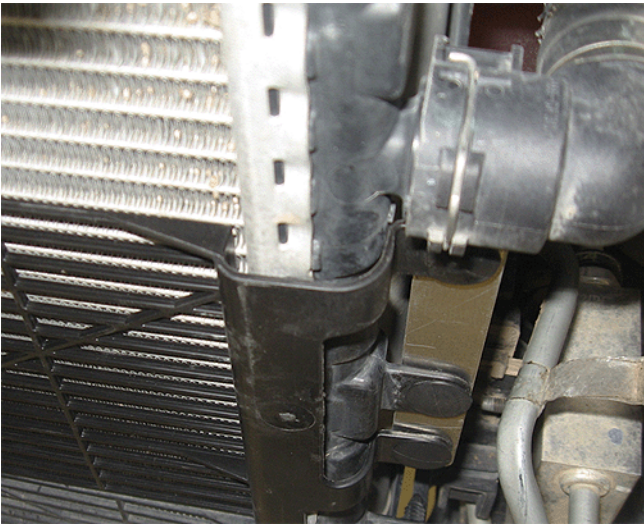
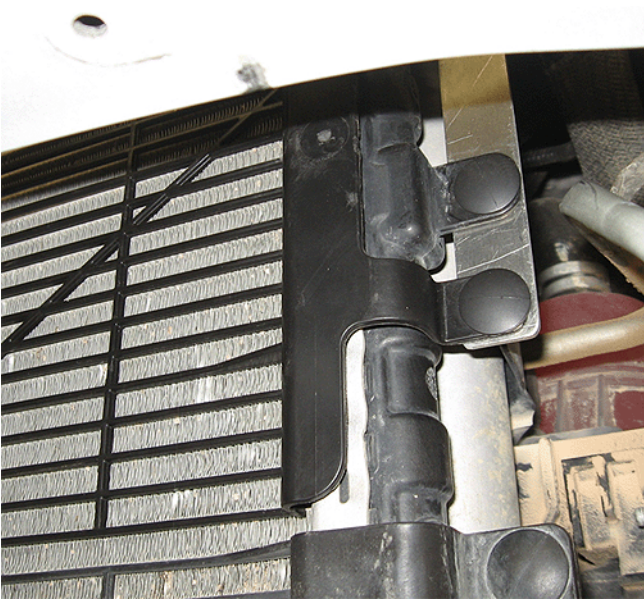
7. Place the grille screen with mounting brackets attached on the new radiator above the existing screen. Align the screen so that the tubes on the radiator are covered and mark the hole locations that will attach to the existing tabs at each end of the radiator.

8. Drill the holes as marked using a 6.25 mm (0.250 in) drill bit.

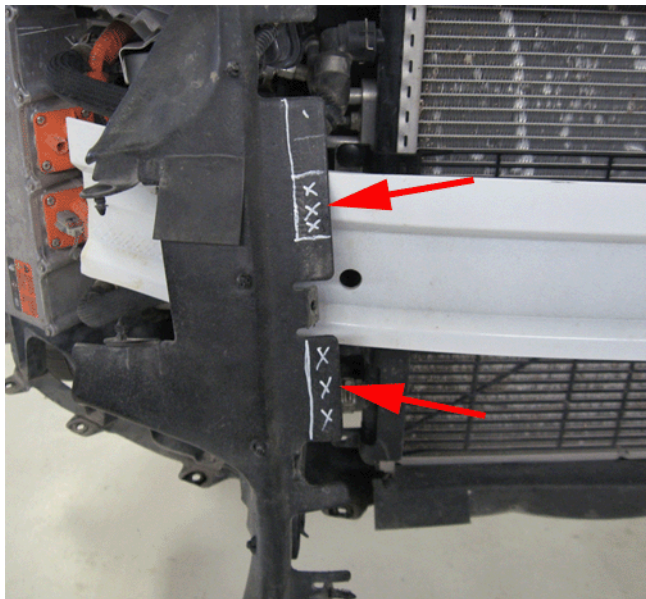
10. Modify the right and left radiator air side baffles by removing the material as shown.
11. Install the new drive motor battery coolant radiator. Refer to the Drive Motor Battery Coolant Radiator Replacement procedure in SI.
