Service Bulletin

Subject: Tick, Buzz or Rattle Noise from Front of Dash, Transmission Filler Tube Cracked or Broken

Models: 2007-2013 Cadillac Escalade Models (excluding Hybrids)
2007-2013 Chevrolet Avalanche, Silverado, Suburban, Tahoe (excluding Hybrids)
2007-2013 GMC Sierra, Yukon Models (excluding Hybrids)

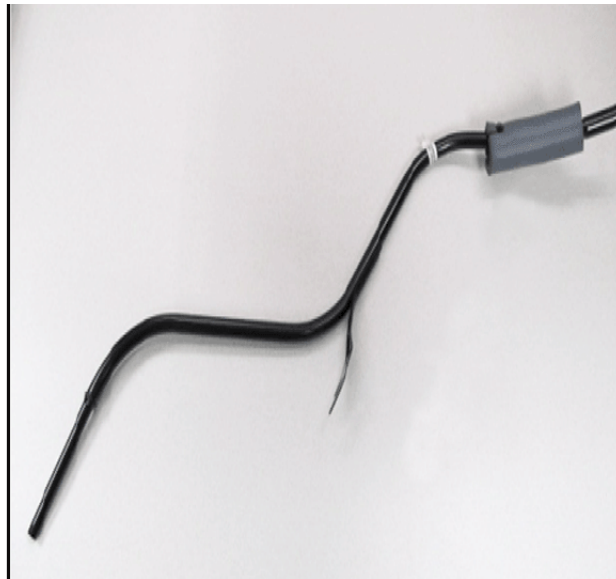
Note: The tie strap threads between the fill tube and half the foam damper using the slot in the sleeve. This is secured to the top half of the tube, leaving the lower half of the damper free.

6. Install a foam damper (sleeve) on the upper end of the transmission filler tube using a tie strap. Refer to the illustration.
7. Install the transmission dipstick.
8. Close the hood.
