Service Bulletin

Subject: Information and Additional Diagnostics on "Park Assist Blocked See Owner's Manual" Message

Models: 2010-2013 Cadillac Escalade Models
2010-2013 Chevrolet Avalanche, Silverado, Suburban, Tahoe
2010-2013 GMC Sierra, Yukon Models
Equipped with Rear Parking Assist (RPO UD7)

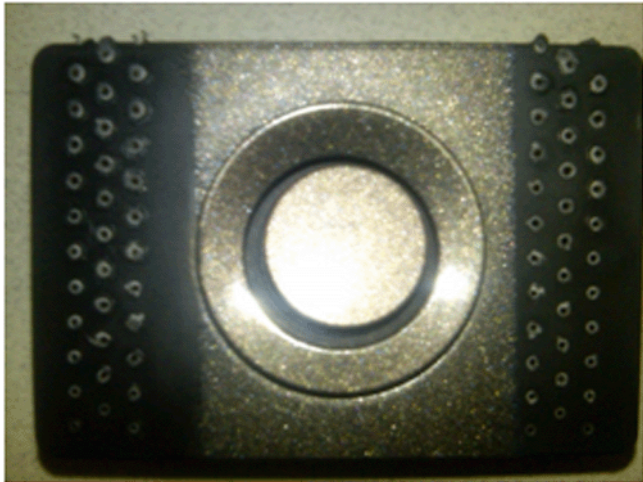
Example #2 – Sensor Centered in Bezel

Ring Down Time too long	One or more of the sensors may be covered or in contact with snow, mud, ice, frost or other debris. Also, frost or ice can form around and behind the sensors and may not always be seen. Typical example is going through a car wash in cold weather leaving a thin coat of ice between sensor and bezel/fascia.	Yes	Yes	Explain normal operation to customer. Refer to Owner's manual for normal operation. Remove snow, mud, ice, frost or other debris from sensor and bezel/fascia especially in the area around the sensor near the bezel/fascia.
	Bezel not fully seated and tabs not extended applying pressure on sensor causing misalignment and allowing the front surface of sensor to come in contact with Fascia/Bezel.	No	Yes	Verify that bezel locking tabs are fully engaged See Example #1 below.
	Bezel/retainer coming in contact with Sensor face	No	Yes	Reposition sensor and align it to center of bezel or retainer. See Example #2 below.

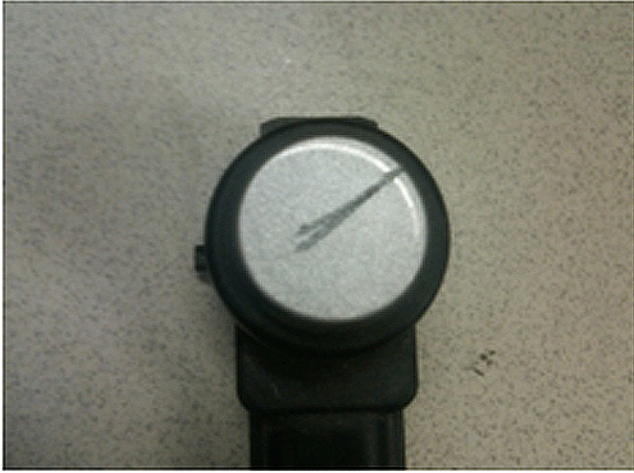
- One or more of the sensors may be scratched or the paint maybe chipped (See Example #5 below).
 - Excessive paint thickness on a sensor may cause an excessive sensor ring time. When replacing or refinishing a sensor, do not apply an excessive amount of paint or clear coat.

Example #5 – Sensor Scratched, Paint Chipped or Excessive Paint

Damaged to bezel or retainer	No	Yes	Replace Bezel/retainer See Example #3 below.
	Silicone insulator surrounding sensor may be missing, cut, or twisted.	No	Yes	Replace sensor insulator ring if damaged. See Example #4 below.
	One or more of the sensors may be scratched, the paint may be chipped or excessive paint on sensor that is greater than 6 mils thickness.	No	Yes	Replace sensor. Refer to Rear Parking Assist Alarm Sensor Replacement procedure. See Example #5 below.
	Improperly installed sensor, sensor may be crooked due to a tight wire harness.	No	Yes	Re-install sensor and correct harness strain on sensor.
	Out of round or jagged hole in fascia causing mechanical contact with painted surface of sensor	No	Yes	Make repair to fascia by removing any mechanical contact between fascia and painted surface of sensor
	Sensor fell out of retainer/bezel with sensor point toward ground or inside rear of bumper/fascia	No	Yes	Re-install sensor and verify sensor is centered in bezel/retainer. See Example #6 below.

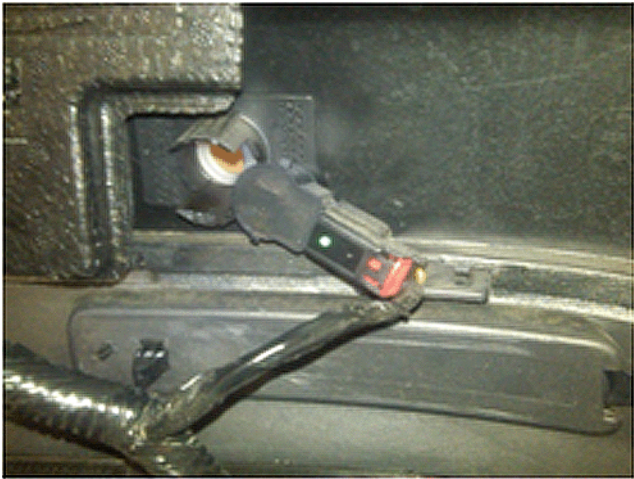
Example #6 – Sensor Detached from Bezel

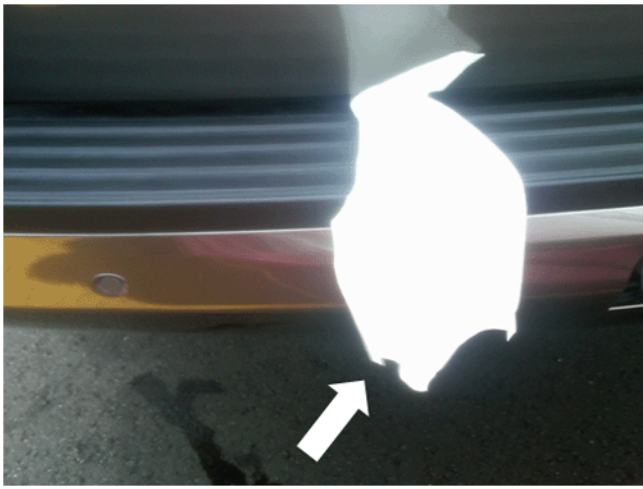
Example #7 – Object Blocking Sensor
