Service Bulletin

Subject: Information on Duramax Flywheel Housing Seals

Models: 2010-2012 Chevrolet Express
2011-2012 Chevrolet Silverado 2500HD/3500 Series
2010-2012 GMC Savana
2011-2012 GMC Sierra 2500HD/3500 Series
Equipped with 6.6L Diesel Engine RPO LGH or LML

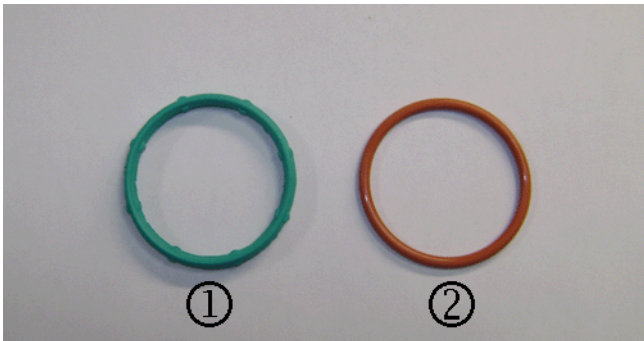
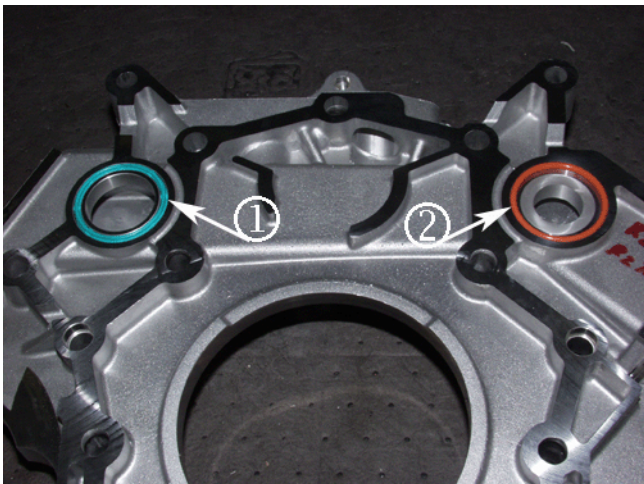
Some vehicles equipped with the Duramax™ Diesel were involved in a mid year change. Some of the vehicles may have been built with a flywheel housing that uses two different style seals; a left (2) and a right (1) one as installed.

On affected vehicles that need these seals replaced (for example; if coolant is leaking out of the rear cover), the left (as installed) seal is an orange O-ring (2), GM♦P/N♦94056175, and the right seal is a blue/green (1) press-in-place seal, GM♦P/N♦12644448.

The machining of the flywheel housing for each style of seal is different and not cross compatible. If the flywheel housing is removed for service, replace the seals with the appropriate part in the right area.
