Corrosion of threaded connection between stainless steel underride guard and front and rear bumper

Topic number	LI88.20-P-053585
Version	1
Design group	88.20 Bumpers
Date	03-25-2013
Validity	X164 with code (U89) Offroad appearance package code (900) Chrome package
Reason for change	
Reason for block

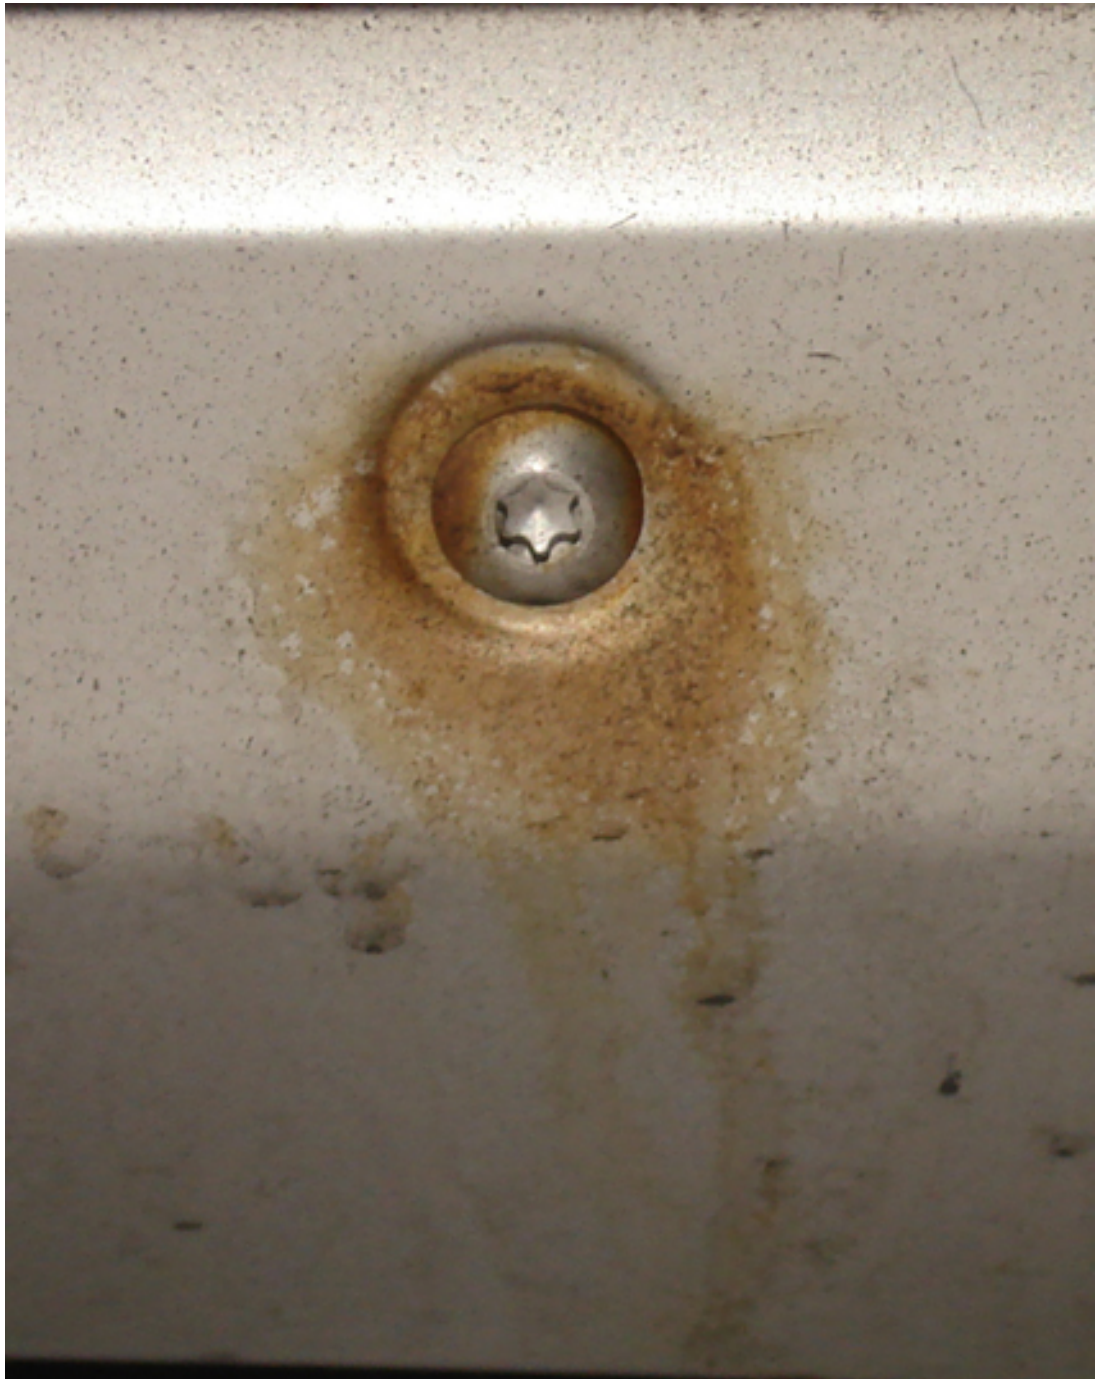
Schadensbild.jpg:

Corrosion of threaded connection between stainless steel underride guard and front and/or rear bumper (see Figure 1).

Attachments	
File	Designation
Schadensbild.jpg	Corrosion of threaded connection for underride guard

Corrosion due to inadequate bolt quality.

Thoroughly clean underride guard with suitable polish; replace bolts

Important: Use plastic washers otherwise the chrome plating will be damaged when the bolts are tightened. Do not use wax!
