# Service Bulletin

**Subject:** Front Sunroof Sunshade Will Not Latch in Closed Position

**Models:** 2010-2014 Buick Enclave  
2010-2014 Chevrolet Traverse  
2010-2014 GMC Acadia  
2010 Saturn OUTLOOK  
Equipped with Sunroof RPO C3U  
and Built After August 1, 2009

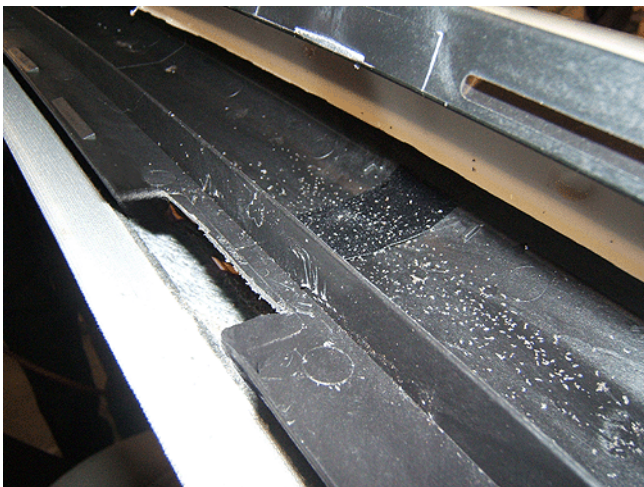
1. Check that the sunroof sunshade striker fits into where the broken striker was by placing the sunroof sunshade striker under the bottom of the front rail. File to fit if necessary.
2. Place the sunroof sunshade striker on the top surface of the front rail to locate the holes.

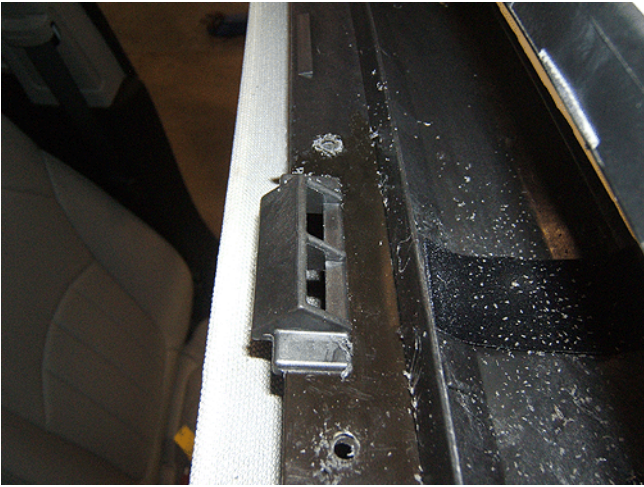
3. Drill two 4.5 mm holes.
4. Place the sunroof sunshade striker on the bottom surface of the front rail.

**Important:** When drilling holes, be careful not to drill through the headliner.

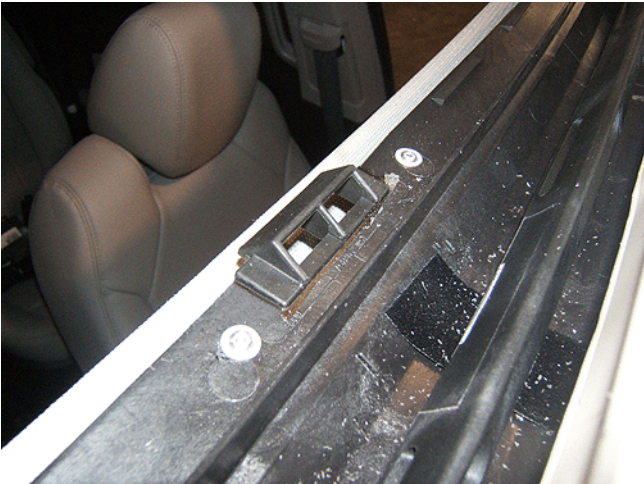
5. Install rivets from the top side to secure the sunroof sunshade striker in place.
6. Verify striker operation.
