# Service Bulletin

**Subject:** Active Fuel Management (AFM) Transition Noise/Vibration Through Exhaust

**Models:** 2011-2013 Chevrolet Caprice PPV  
Equipped with 6.0L Engine (RPO L77)

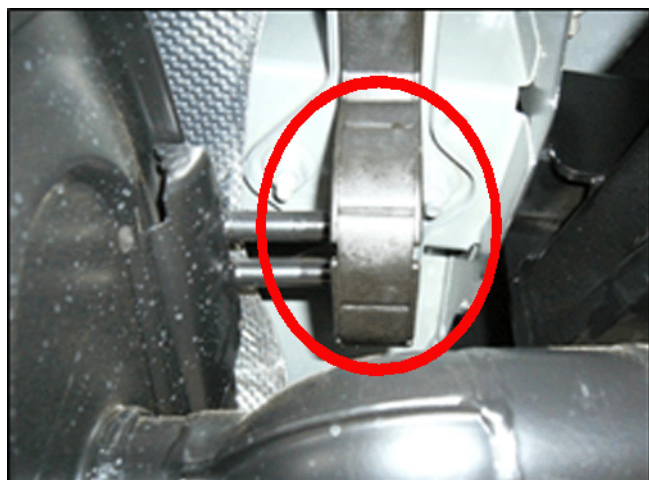
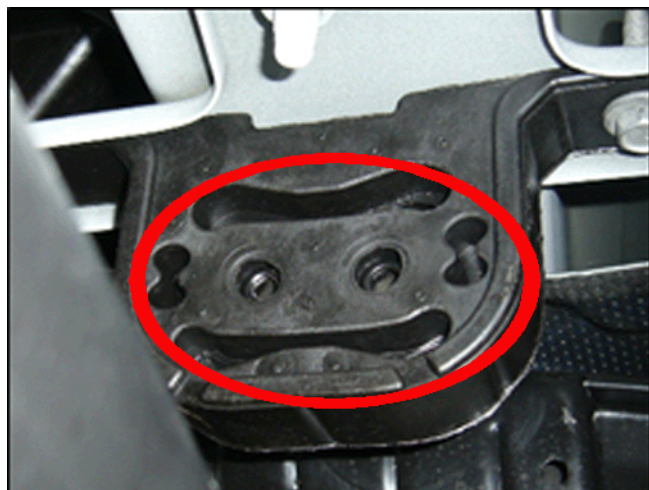
A tell tale sign the exhaust system is bound up is that the exhaust hangers may not pass all the way through the insulators at the rear of the vehicle. For example, the exhaust may be too far forward as shown in the illustrations above.

**Important:** After verifying that the customer complaint vehicle has the condition as described above, disassemble the flanged exhaust joints and reassemble as per the sequence below.

Disconnect the exhaust system at the catalytic converter to intermediate joints.

The rear section of the exhaust system can now be pushed rearward and also aligned so that it is central to the vehicle. The flexible catalytic converter joints will need to be pushed through their cycle of motion to ensure they can move freely.

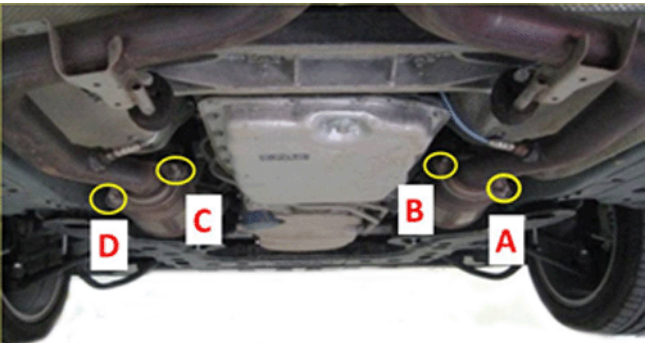
Do not replace exhaust components for this condition. It can be rectified by correctly aligning the exhaust system and sequential torquing of the exhaust clamp rings by hand. The assembly order for the exhaust system shown in the installation above is(A, D, B, C).

Once done, the catalytic converter to intermediate joints must be re-tensioned to 45 Y (33 lb ft) in an outboard to inboard sequence. This will ensure a central location for the entire exhaust system.

**Important:** DO NOT use air or power tools. This will ensure the load is evenly distributed over the entire section of the clamp ring, keeping the exhaust alignment as intended.
