NUMBER: 23-007-13

Mopar '11 Shifter Handle Contacting Bezel

2011 (LD) Charger

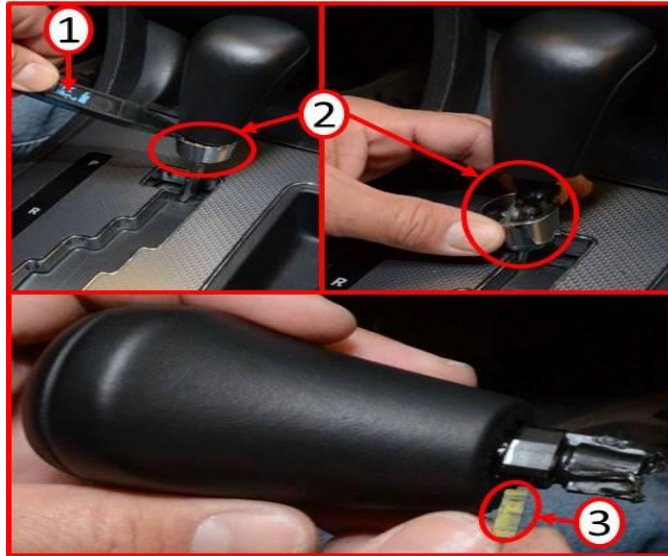
Fig. 1 Shift Knob Removal

- 1 - Trim Stick
- 2 - Shift Knob Trim Ring (Standard Shift Knob Shown)
- 3 - Retainer Pin (Base of Shift Knob)

- Using a trim stick (1) remove the shift knob trim ring (2) to gain access and remove the retaining pin (3) from the base of the shift knob (Fig. 1). Remove the shift knob.

NOTE: The pistol grip shift knob may require the removal of the side grips to access its retaining point to allow removal of the knob.

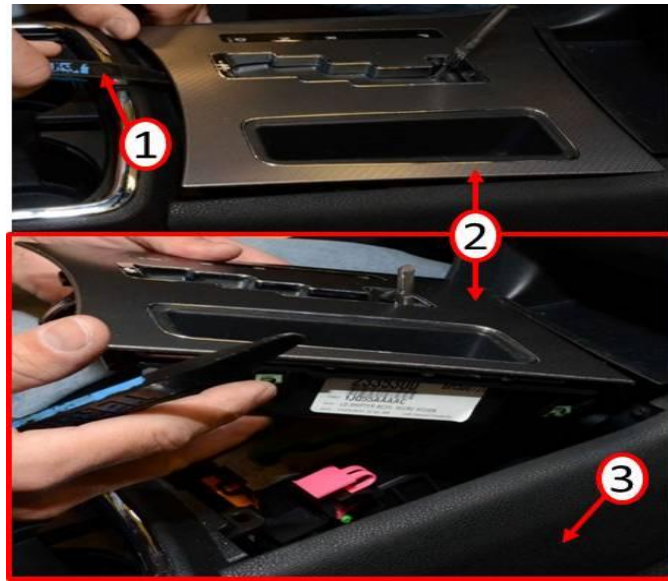
Fig. 2 Shifter Bezel Removal

- 1 - Trim Stick
- 2 - Shifter Bezel
- 3 - Floor Console

-
- Using a trim stick (1) gently pry between the shifter bezel (2) and the floor console (3) to release the snap retainers that secure the bezel (Fig. 2).

NOTE: Do not fully remove the bezel until the shifter bezel wiring harness has been disconnected. Avoid excessive force to remove the bezel.

NOTE: If the shifter bezel is damaged from shift knob contact it should be replaced using p/n 68147017AB.

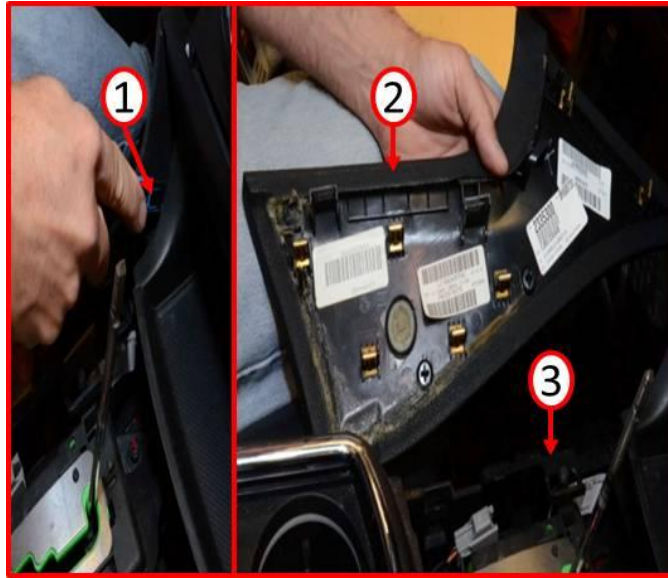
Fig. 3 Console Side Cover Removal

- 1 - Trim Stick (Front Console Storage Bin)
- 2 - Console Side Close Out Panel
- 3 - Floor Console

-
4. Using a trim stick gently pry between the front console storage bin (1) and the floor console side close out panel (2) to release the two snap retainers that secure the close out panel to the instrument panel and remove both console side close out panels (Fig. 3).

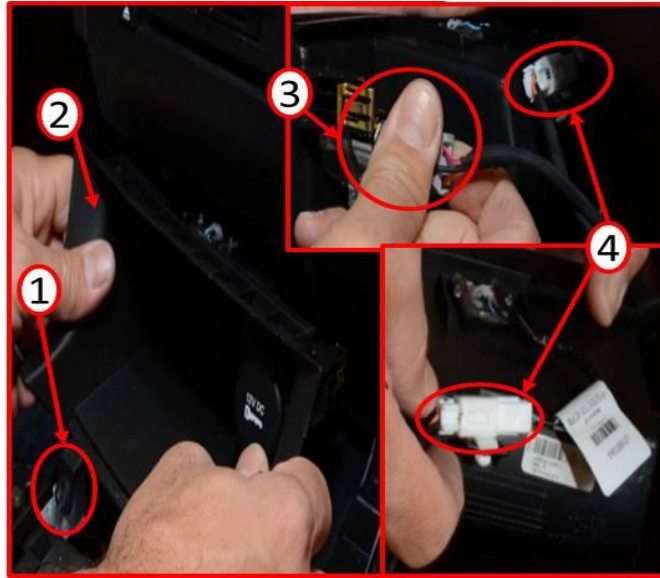
Fig. 4 Console Storage Bin Removal

- 1 - Front Retaining Tab
- 2 - Console Storage Bin
- 3 - 12V Power Outlet Wiring Harness
- 4 - LED/Lamp Wiring Harness

-
- 5. Remove the two screws securing the storage bin retaining tabs (1) to the front console (Fig. 4).
 - 6. Disconnect the 12V power outlet wiring harness (3) from the rear of the storage bin (Fig. 4).
 - 7. Disconnect the LED/Lamp wiring harness (4) from the rear of the storage bin and remove the storage bin (Fig. 4).

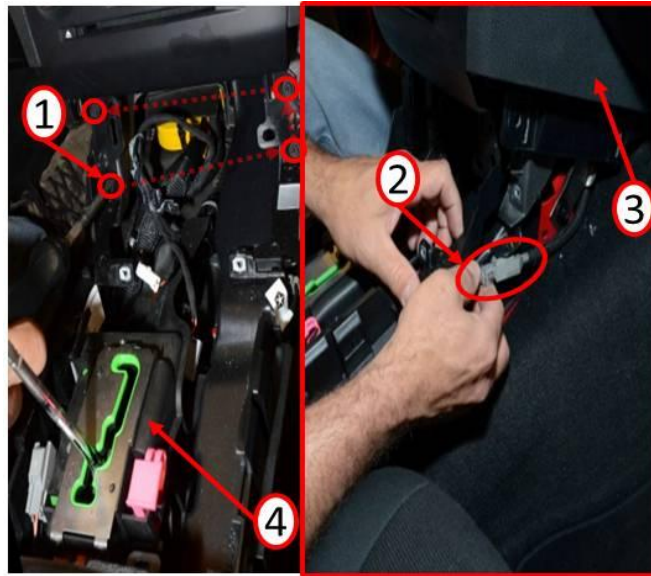
Fig. 5 Reposition Console

- 1 - Front Console Retaining Screws
- 2 - USB Jumper Harness
- 3 - Instrument Panel
- 4 - Shifter Assembly

-
- 8. Remove the four screws (1) that secure the front of the console to the instrument panel (3) ([Fig. 5](#)).
 - 9. If equipped, disconnect the USB jumper harness (2) ([Fig. 5](#)).

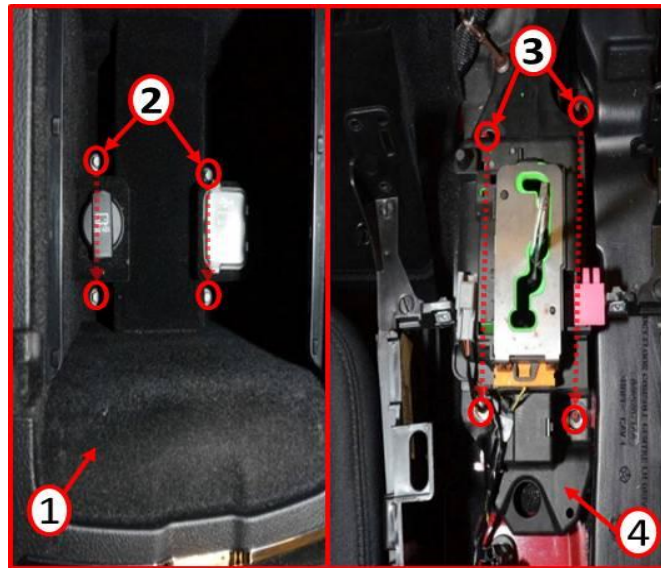
Fig. 6 Console Reposition and Shifter Removal

- 1 - Rear Bin (Floor Console)
- 2 - Rear Console Bin Retaining Screws
- 3 - Shifter Retaining Nuts
- 4 - Shifter Assembly

-
10. Remove the four screws (2) from the rear bin that secure the floor console (1) to the floor panel transmission tunnel and slide the floor console rearward.
 11. Remove the four retaining nuts (3) securing the shifter assembly (4) to the floor panel transmission tunnel and remove the shifter assembly.

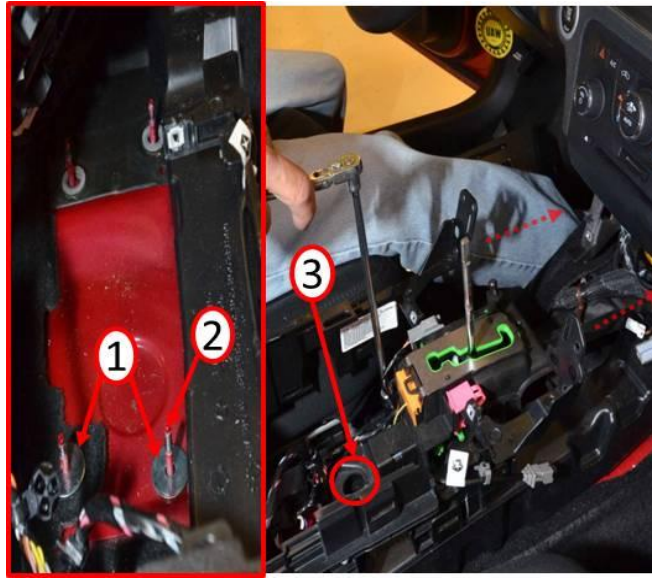
Fig. 7 Shifter Shim Installation

- 1 - Washer (P/N 06106668AA)
- 2 - Shifter Retaining Stud
- 3 - Floor Console Locating Hole (Shifter Assembly)

12. With the shifter removed, place a washer (P/N 06106668AA) (1) on each of the rear shifter retaining studs (2) and reinstall the shifter.

- 13. Slide the floor console forward ensuring the locating pin on the console is seated in the locating hole of the shifter assembly (3) to ease reinstallation.
- 14. Reverse the procedure for reassembly.
