**No.: 13 TS-3**  
January 31, 2013

SUBJECT: **DD Platform Camshaft Housing With Scored Journals**

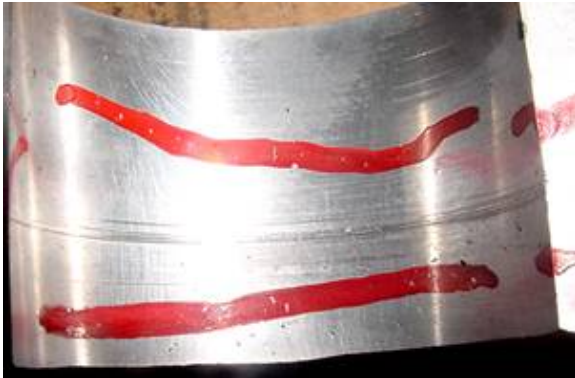
Debris score marks may be seen on the camshaft housing journal surfaces. Few or single score marks are typically caused by fine metal chips being flushed through the system from the initial new engine build. These individual score marks should be ignored as the design robustness will handle it without any problems.

Single Score Mark-Normal

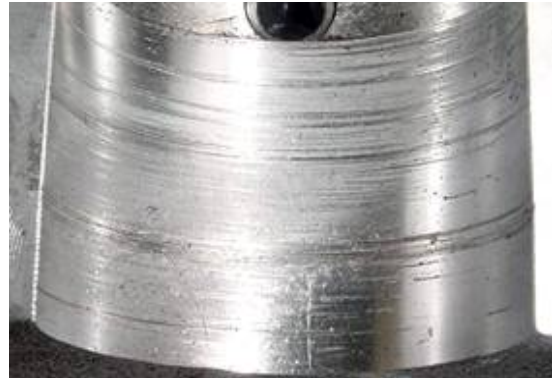
40% Score Marks-Normal

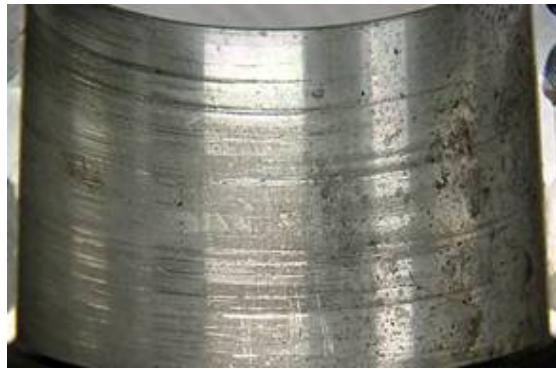
60% Score Marks-Abnormal

If scoring is across 60% or more of a single journal surface, then the surface should be considered to have been compromised, and replacement is recommended. Note that if severe scoring is found, this is an indication of debris contamination, and the root cause should be investigated. See Table 1 for examples of normal and abnormal camshaft housing journal wear.
