## Vehicle Owner Notification

**Subject:** VON # 80- Heater/Defroster 1 Fuse Replacement

## VEHICLE OWNER NOTIFICATION #80

**SUBJECT:** HEATER / DEFROSTER FUSE REPLACEMENT

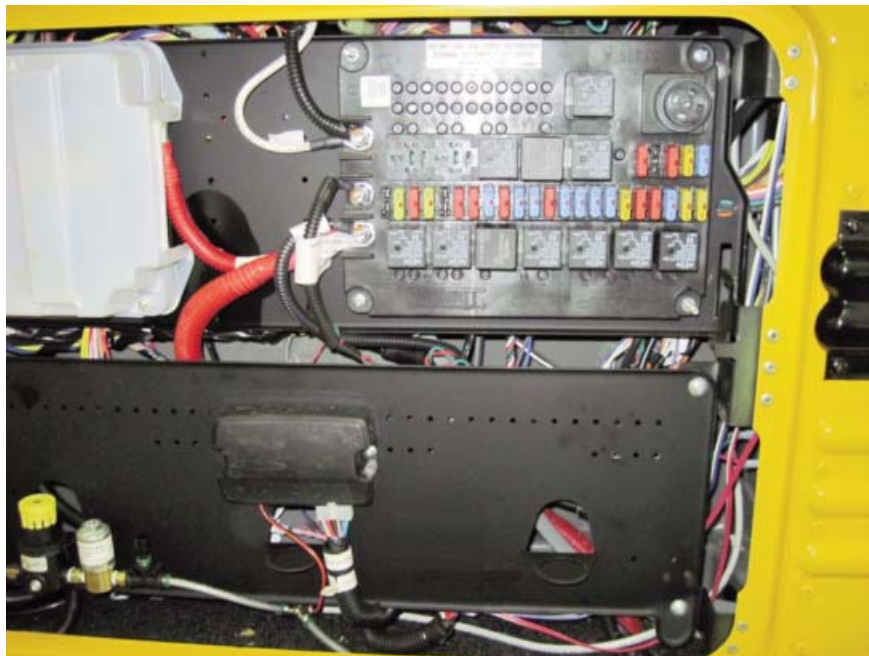
**FIGURE 1**

1. Turn the ignition key to the "Off" position. Chock the tires and disconnect the batteries.
2. Open the exterior electrical panel access door below the driver's window.
3. Remove the PC Board #1 cover, if present. **Figure 1**

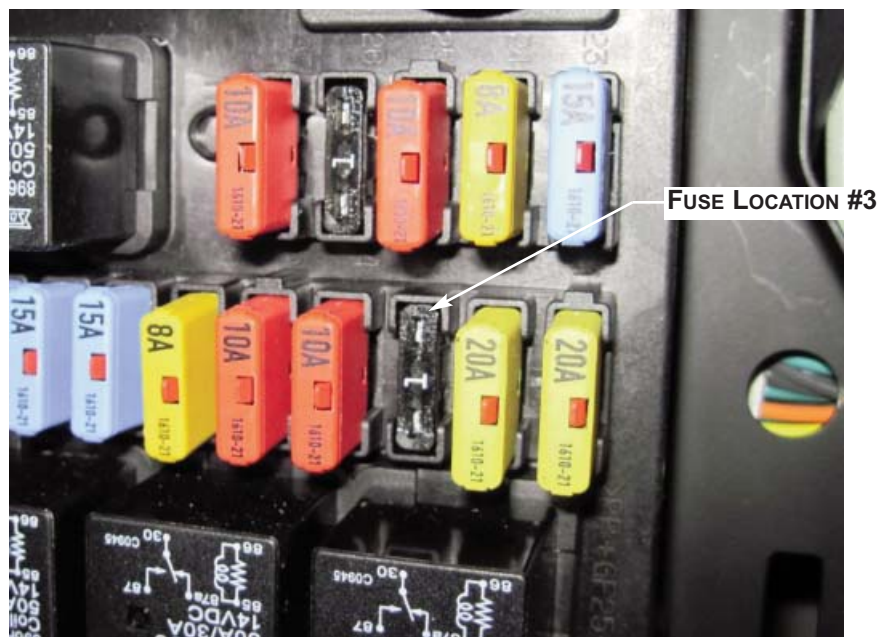
**FIGURE 2**

4. Locate the fuse or circuit breaker in locations #3 on PC Board #1 and replace it with a 1 amp fuse - TBB 151450. **Figure 2**

5. Reinstall the PC Board cover, if present, and close the exterior electrical panel access door.
6. Connect the batteries and remove the tire chocks.
