Vehicle Does Not Start: Loose Ground Z6000*4B

F30 with N20

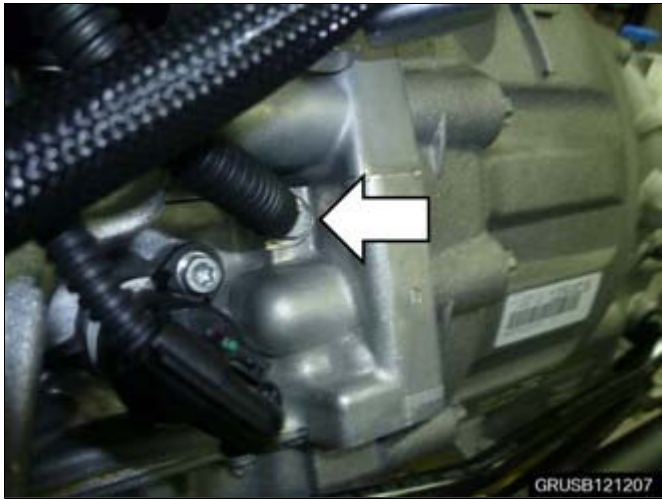
The ground point Z6000*4B on the engine block near the starter is loose.

| | <ol style="list-style-type: none"> 1. Check and tighten the ground point Z6000*4B to 8 Nm, located on the engine block near the starter. 2. Clear all fault codes that might have been stored if the ground was found to be loose. |
