SI B36 03 13
Wheels and Tires

Service Action: Continental Tires, Inspect and Replace if Necessary

F30

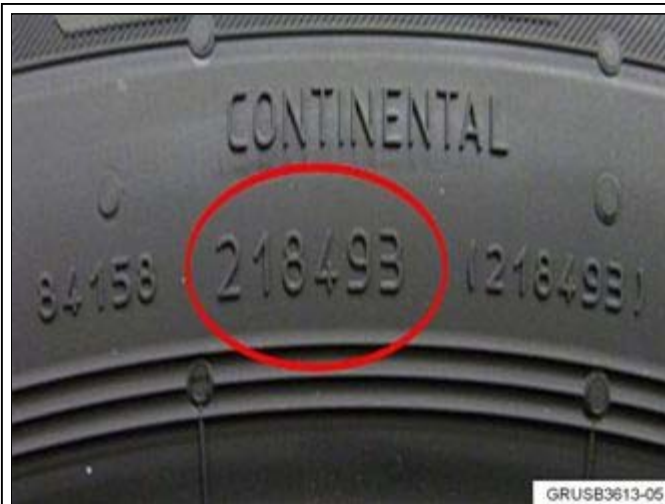
Check for the affected mold number:

Only tires with mold number **218493** are affected.

If the identification mark **218493** is present, continue with the **DOT number check**.

Tires with identification marks from other molds are not affected. No other measures are necessary in this case.

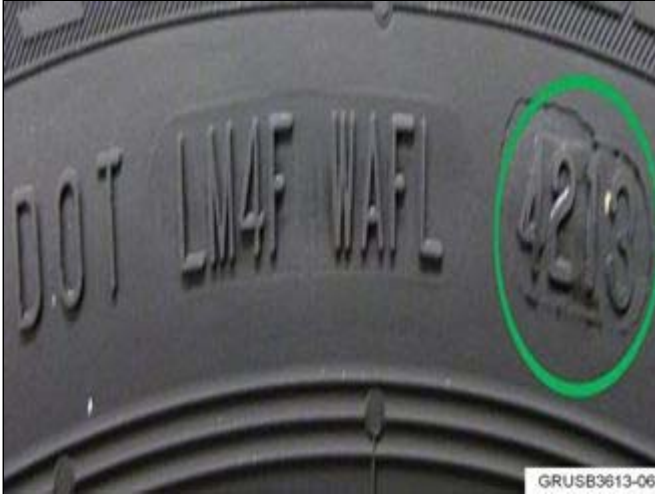
DOT Number

Only the tires with DOT numbers **3913, 4013 or 4113** are affected.

Tires with other DOT numbers, such as 4213 (shown here), are not affected.

Replace the affected tires.

IMPORTANT: Replaced tires should be damaged beyond repair to ensure they are not reused.

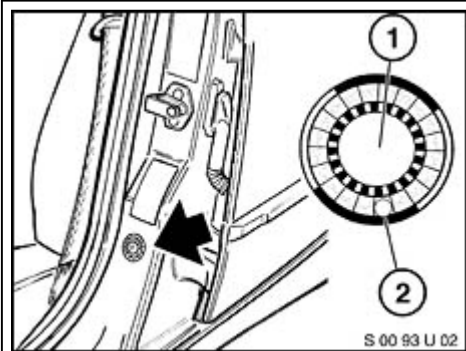
This Service Action has been assigned code number **659**. After the vehicle has been checked and/or corrected, obtain a label (SD 92-420) and:

- A. Emboss your BMW center warranty number in the middle of the label (1);
- B. Punch out code number **659** (2), printed on the label; and
- C. Affix the label to the B-pillar as shown.

If the vehicle already has a label from a previous Campaign, affix the new label next to the old one. Do not affix one label on top of another one because a number from an underlying label could appear in the punched-out hole of the new label.
