SI B65 20 13  
Audio, Navigation, Monitors, Alarms, SRS

### Vehicle in a Transport Mode Cannot Be Unlocked with Remote Control

F15

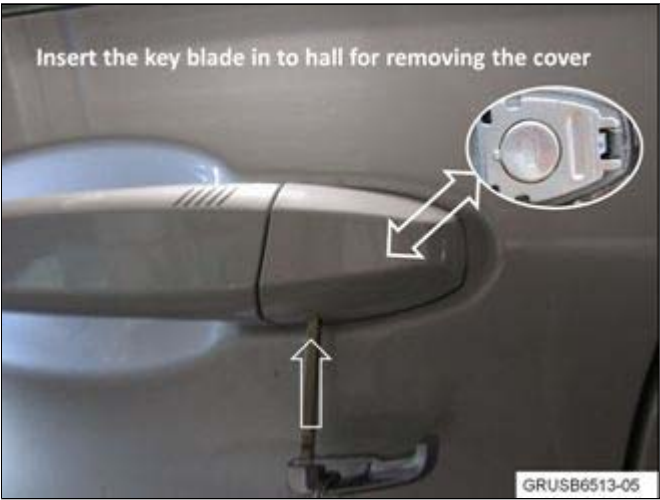
| | <ol style="list-style-type: none"><li>1. Remove the mechanical key (blade) from the remote control.</li><li>2. Protect the cap cover and door area to avoid scratching or damage.</li><li>3. Insert the key blade into the driver's side door handle cover cap to release the cap, as shown in the photo.</li><li>4. Press on the cover cap and push slightly to the right to remove it.</li><li>5. Under the cover, insert the key into the key slot. Unlock the vehicle manually.</li></ol> |

- Some vehicles can be woken up by using the rear tail gate switch; once this is done, the remote will unlock the vehicle.
- If the above procedure does not work, the vehicle must be unlocked manually with the mechanical key, using the following procedure:
