Incorrect Customer Relations Telephone Number Is Saved in the Vehicle

R55

R56

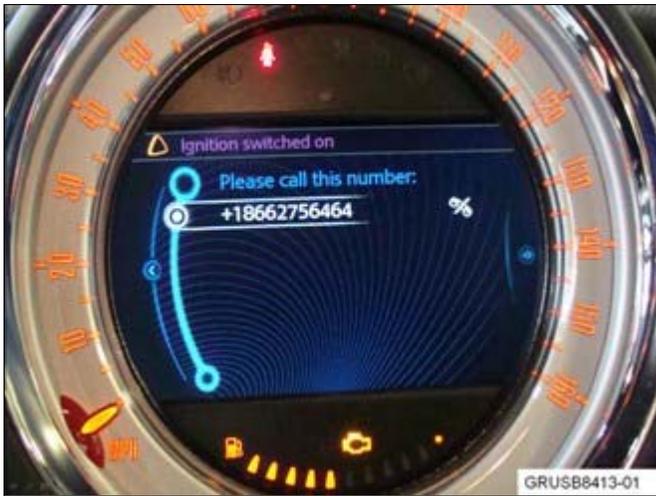
5. This picture shows the **correct** number stored in the Combox control unit.

Note: To read out telephone number:

- a. Press the Home/Menu button.
- b. Use the joy stick controller and select MINI Connected.
- c. Scroll to Customer Relations, and then push down on the controller.

1. Connect the vehicle to ISTA.
2. The path to the test plan is: Activities / Service Function / 05 Maintenance and Pre-Delivery Check / CBS Correction, vehicle data / Search.
3. Select the test plan titled “CBS vehicle data correction” from the list.
4. Select “Change vehicle data.”
5. After the test plan sets the date and time, the next page displayed will list the CBS data information. Scroll to the bottom of the page and select “Change telephone numbers.”
6. Then select “Technical Support.”
7. Write the number in the following format (+18662756464).

8. Verify that the correct number is now stored in the vehicle.

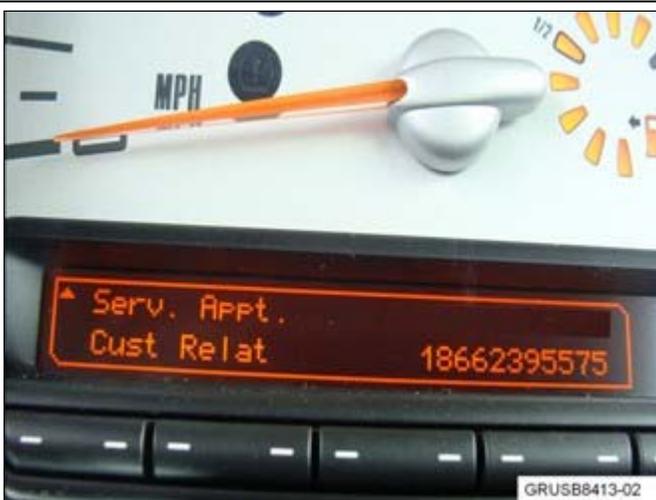
6. This picture shows the **incorrect** number stored in the radio.

Note: To read out telephone number:

- a. Press the menu button.
- b. Select MINI.
- c. Scroll to “Cust Relat.”
