2012FA06C, Rev. A  
October, 2012  
Product Code(s): 63  
Page 1 of 4

SUBJECT: C5 Clutch Compressive Fatigue Inspection

MODELS AFFECTED: 1000 and 2000 Series Transmissions

VOCATIONS AFFECTED: Non SEM/LRTP Transit Bus

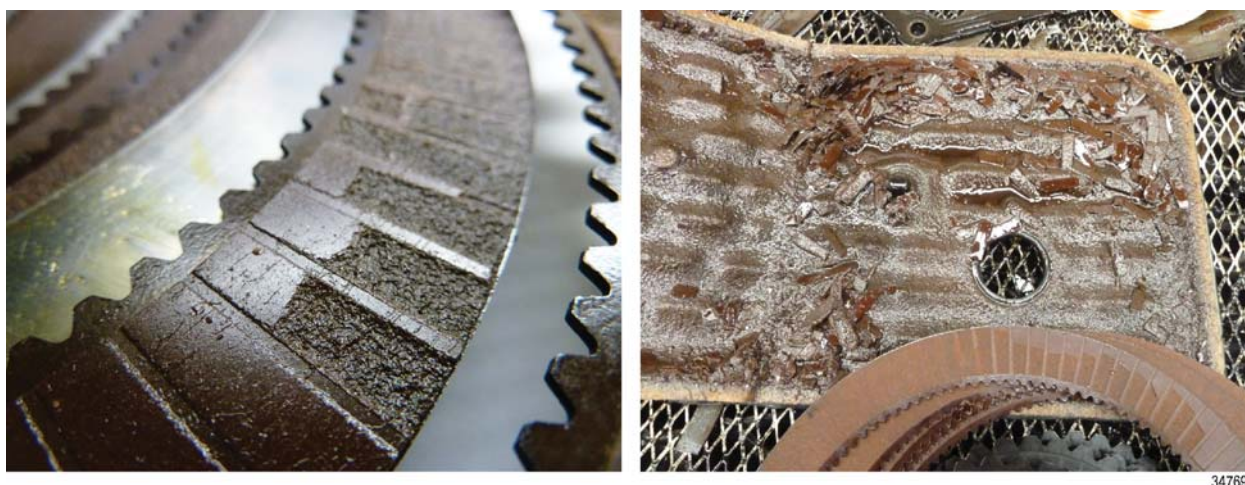
**Figure 1.**

Allison Transmission, Inc. has identified an issue which could limit the life of the C5 clutch in 2100 Series Transit Bus vocations. A higher C5 pressure strategy was implemented with the 2010 Uprate Controls which, over time, may cause friction material loss on the C5 friction plate. Field Action 2012FA06C is an inspection process to define remaining clutch life by comparing the friction clutch plates to the duty cycle of the C5 clutch.

Inspect the C5 clutch friction plates. If compressive fatigue is present (refer to [Figure 1](#)) and C5 clutch friction plate debris has contaminated the transmission, then continue the disassembly. Rebuild the transmission, replace the torque converter and flush the transmission cooler.

If the C5 clutch friction plates look acceptable, then tie the plates together and mark with the serial number and identification so the Static Data File can be traced to these C5 clutch friction plates. A Return Materials Authorization (RMA) will need to be created and the C5 clutch friction plates need to be sent to Allison Transmission Global Headquarters (shipping information included on the (RMA) template below).

Install new C5 clutch friction plates, measure for proper selectable C5 reaction plate and reassemble the unit per 1000/2000 Product Families 2010 Uprate Service Manual (SM5818EN). Reinstall the transmission in the vehicle. Using Allison TCM Reflash (Production Calibration Configuration System (PCCS)), load an updated calibration into the Transmission Control Module (TCM) per Field Action 2012FA06B. If performing both 2012FA06B and 2012FA06C at the same time, two separate claims are required.
