Technical Bulletin

26 13 05 September 24, 2013 **2031583** Supersedes T.B. V261304 dated August 15, 2013 to update Golf labor operation time units.

MIL ON - DTC's P047F, P0477, P048A, P048B, P048C or P0401 Stored in ECM Fault Memory

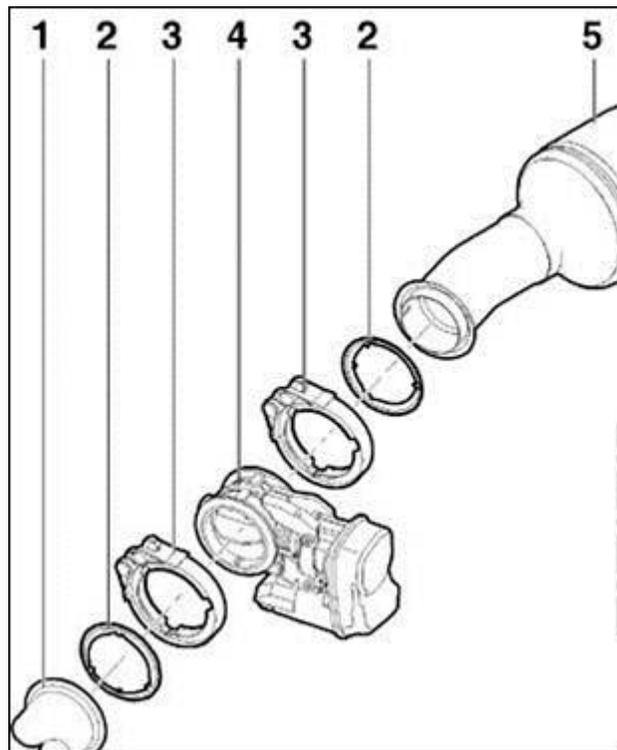
Water and road salt can corrode the exhaust flap shaft causing it to stick in open / closed position.

1. If one or more of the following faults are stored in the ECM fault memory, remove the exhaust flap to check for a sticking condition. (Item 4).

If the flap cannot be moved or does not move freely, the exhaust flap must be replaced.
