SERVICE CAMPAIGN BULLETIN

NTB13-014

VOLUNTARY SERVICE CAMPAIGN 2009 – 2011 STEERING LOCK UNIT

CAMPAIGN ID #: P3208
APPLIED VEHICLES: 2009 – 2010 370Z (Z34)
2009 – 2011 GTR (R35)

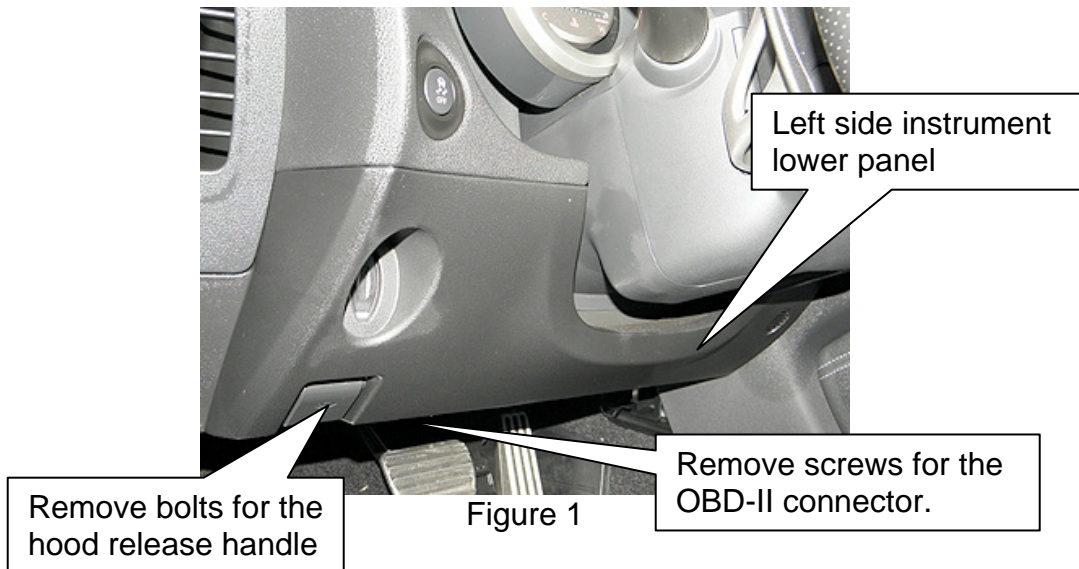
1. Make sure the ignition is OFF.
2. Remove the left side instrument lower panel as follows (see Figures 1 and 2).
 - a. Use a plastic trim tool to snap loose the instrument side finisher LH.
 - b. Remove bolts (1 to 2 depending on model) from the hood release handle.
 - c. Remove screws (1 to 2 depending on model) from the OBD-II connector.
 - d. Use a plastic trim tool to snap loose the left side instrument lower panel.

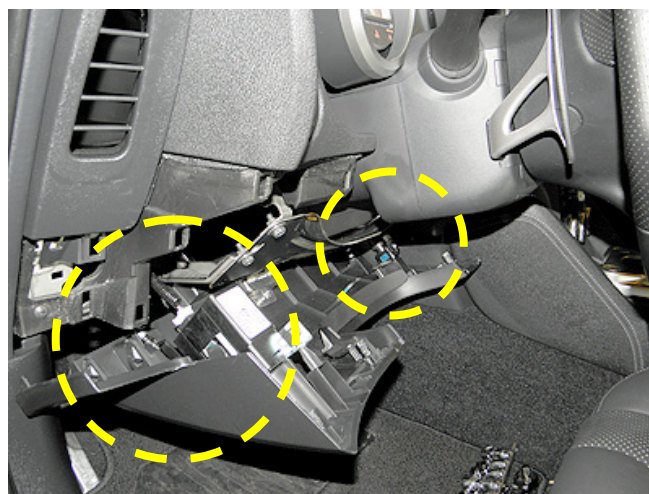
- e. Disconnect the electrical connectors and the climate control tube.

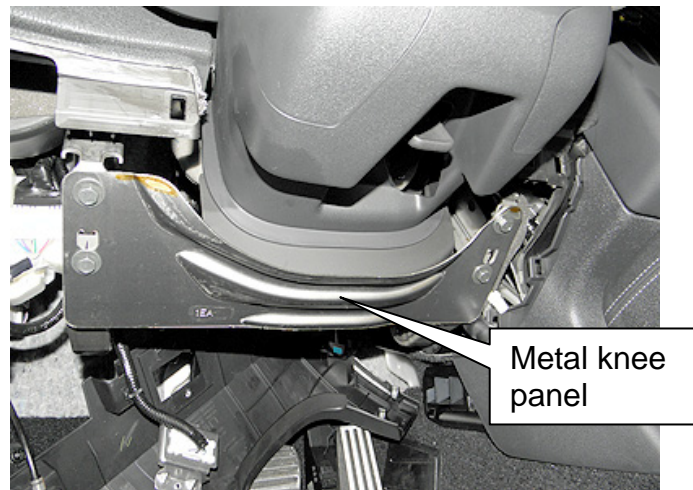
Figure 3

3. Remove the metal knee panel - 4 bolts.
