Dealer Inventory Inspection

2013 Nissan Altima Spare Tire Pressure

Subject: **2013 Nissan Altima Spare Tire Pressure
Dealer Inventory Inspection**

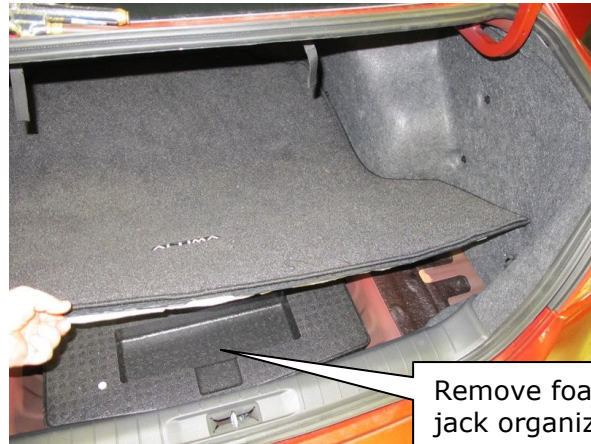
Figure 1

1. Open trunk and lift rear carpet and trunk flooring.
 - Remove foam jack organizer.

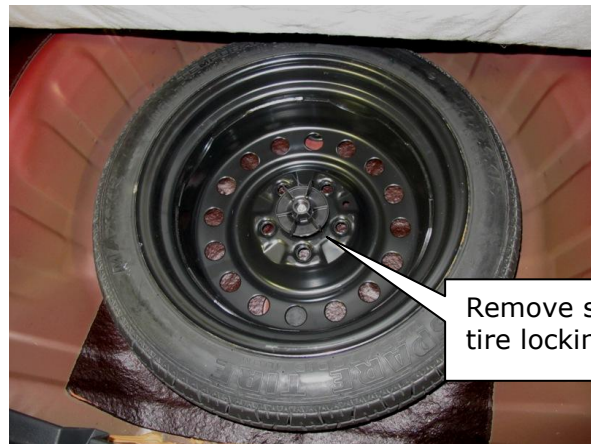
Figure 2

2. Remove spare tire locking bolt and flip tire over to access the valve stem.
3. Check spare tire air pressure.

- If tire pressure is less than or equal to 64 PSI, then adjust tire pressure to 60 PSI and release vehicle, use **Op Code PC2230**.

If tire pressure exceeds 64 PSI, reduce to 60 PSI and release vehicle, use **Op Code PC2231**

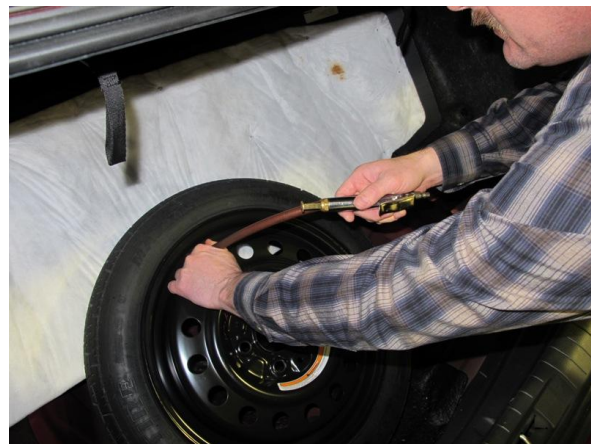
Figure 3

4. Install spare tire in trunk location and secure with locking bolt.
5. Install foam jack organizer.
6. Fold trunk flooring back into place.
