Service Bulletin 491

Affected Models Street Triple and Street Triple R - All Models without ABS

Subject Brake Hose Clip

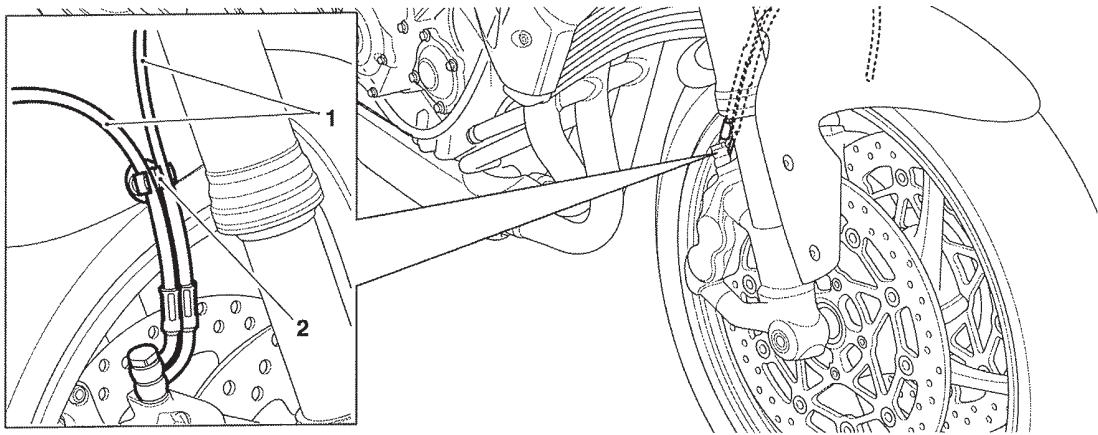
1. Detach the two brake hoses from their retaining clip on the right-hand side of the front mudguard.
2. Carefully remove the clip and retain it as described in the Genuine Parts Return Instructions on page 2.

1. Front brake lines

2. Clip

3. Check the mudguard for damage that may have been caused by the front brake hoses.
4. **For lacquered finished mudguards only:** If the paintwork shows signs of scuffing, due to the brake hoses, apply a preparatory paint polish to the affected area using a soft cloth and work out the scuffing. If the marks can not be removed replace the mudguard and retain it as described in the Genuine Parts Return Instructions on page 2.
5. **For matt finished mudguards only:** If the paintwork shows signs of scuffing, replace the mudguard and retain it as described in the Genuine Parts Return Instructions on page 2.
6. Fit the new clip and secure the two brake hoses to it.
