## Pilling formation (small fiber knobs) on the seat covers

| Topic number | LI91.18-N-048773 |
| Validity | Model 906 |

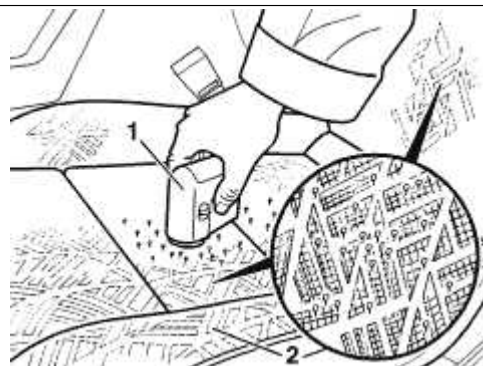
P91\_1\_.18-0240-01.jpg:

Pilling formation (small fiber knobs) on the seat cover fabric.

Fibers loosen from the occupants' clothing (remote pilling) and/or from the fabric of the seat cover (self-pilling) and due to friction from movements, small fiber knobs form on the surface.

| Attachments | |
|---|---|
| P91_1_.18-0240-01.jpg | 1. Lint remover<br>2. Covering |

The pilling (fiber knobs) can be removed easily with a lint remover. They then no longer occur or the tendency to form pills is reduced. There is no danger of further fabric damage (chafing through).

Lint removers are commercially available. It is therefore not necessary to remove seat coverings with pilling. We recommend (e.g. during service) watching out for pilling and removing the pills with a lint remover before the customer complains about it.

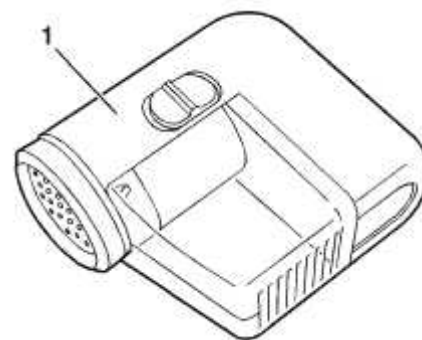
P91\_1\_.18-0241-01.jpg:

| Attachments | |
|---|---|
| P91_1_.18-0241-01.jpg | 1. Lint remover |
