Navigation Micro SD Card Error

2014 IS Models with Navigation

2014	IS250	2014	IS350
------	-------	------	-------

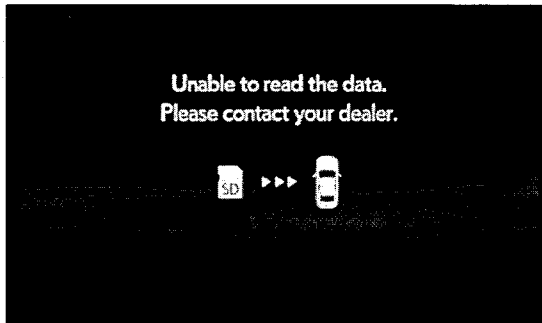
Error message when microSD card is swapped from another vehicle.

- Do not interchange SD cards. Each SD card is “paired” with head unit.
- Once an SD card is paired with a vehicle, it may not be swapped into a different vehicle.
- A new SD card is “unpaired” and becomes “paired” when inserted into a vehicle.
- If an SD card is swapped, returning it to the original vehicle will remedy the problem.

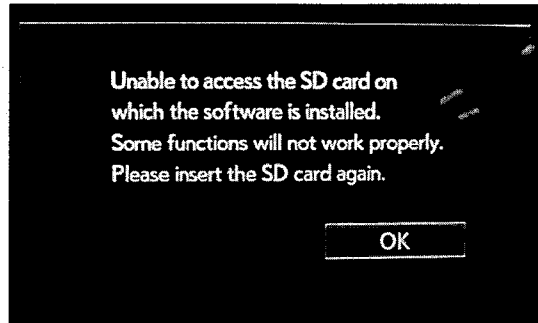
Error message when microSD card is missing.

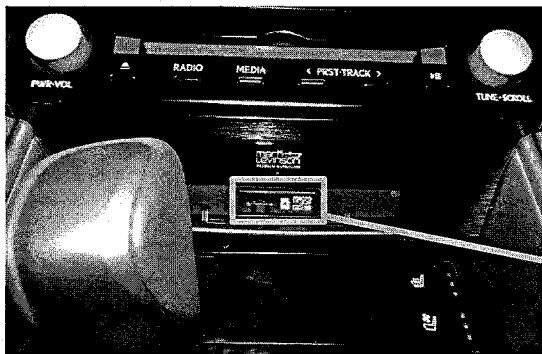
MicroSD card installation location.
