Reference SSM63277

Models LR4 / L319
Range Rover Sport / L320

Title Air suspension fault, warning light on with possibility of additional warning li

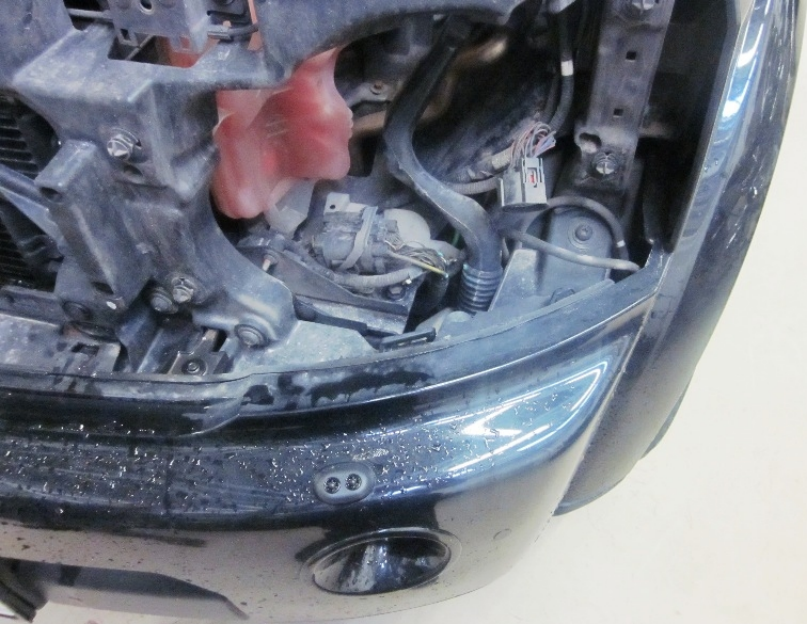
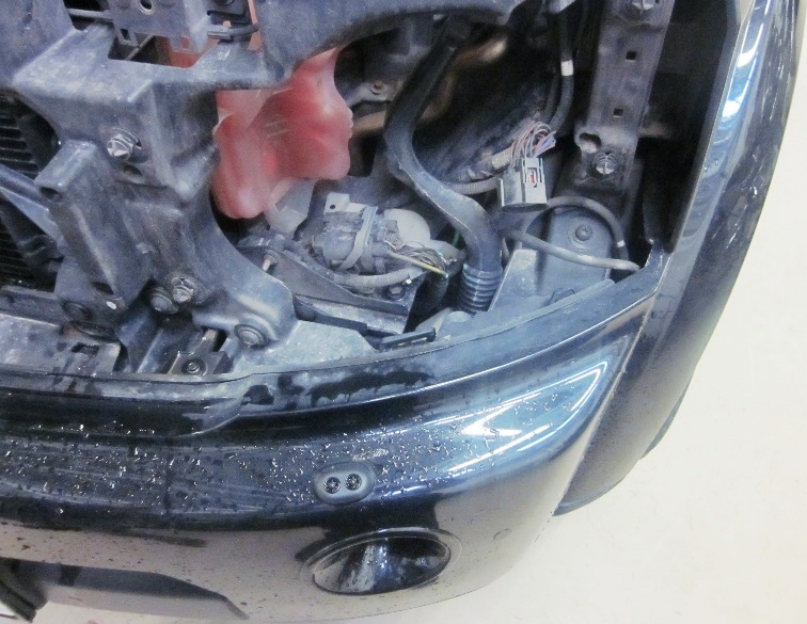
[harness chafe under headlamp\(2\).JPG](#)

[harness chafe under headlamp\(1\).JPG](#)

The harness has been incorrectly routed and is pressing against the washer filler tube causing insulation damage and a short circuit/open circuit

If on initial investigation the air suspension warning light is on and any fault code starting C1A is found using diagnostic equipment especially C1A36-01 it is suggested that you check the harness routing under the LH headlamp. See attached photo for failure mode.

Repairs damaged wires using the harness repair kit and reposition the harness to prevent reoccurrence.
