Service Bulletin

Subject: **Key Switch W000W1037 2nd update**

Product: **F4 - F4 R - F4 RR - MY 2013**

In the commentary make note to the Service Bulletin N°117.

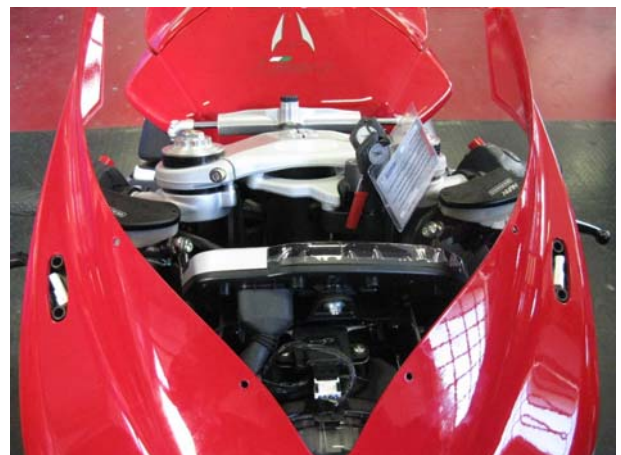
- Remove the windshield

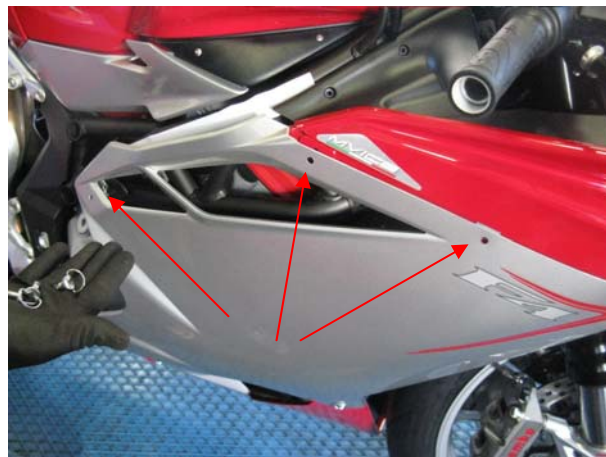
- Remove the 3 fairing fixing screws on both Right and Left fairings as shown in figure.

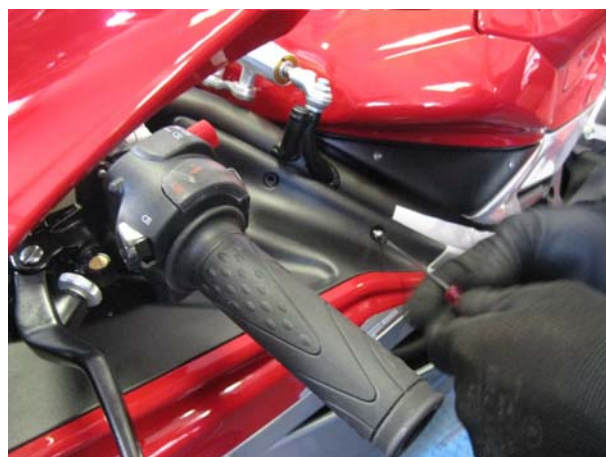
- Remove the Right and Left covers by unscrewing the 2 fixing screws and pulling gently the side fairing in order to facilitate the extraction. **Reconnect** the side fairings in order to avoid any interference with the handlebar during the operation.

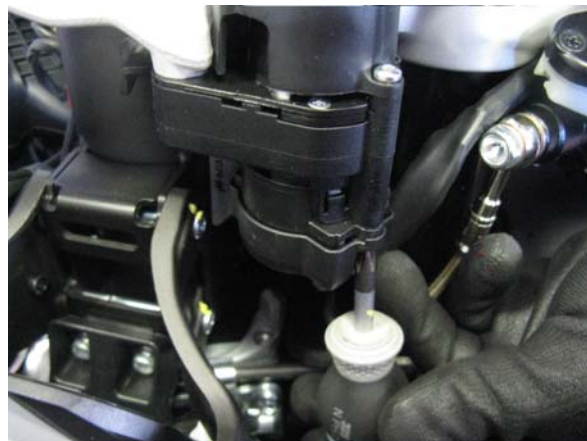
- Remove the little cover under the key switch by loosening the 2 fixing screws.

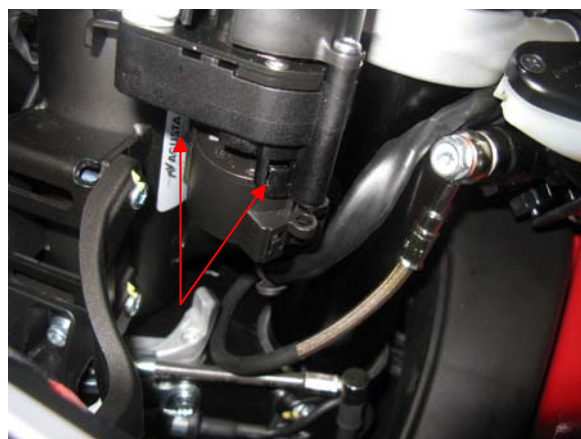
- Disconnect the two clips that are fixing the key switch's electrical part.

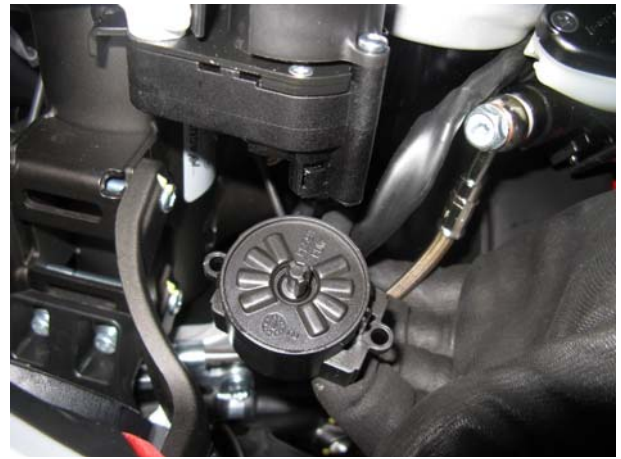
- Remove the Key Switch.

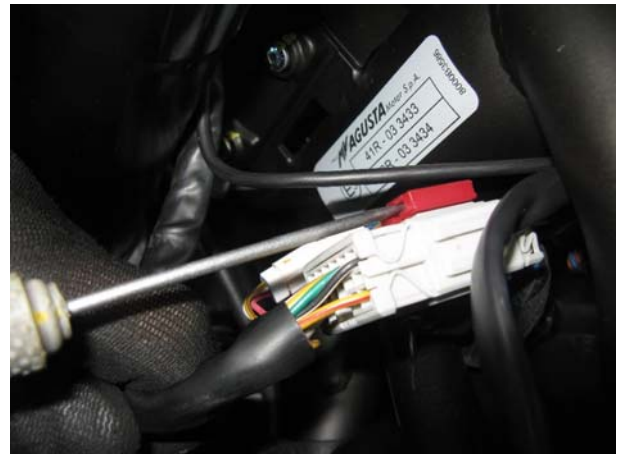
- Remove the white connector as shown in figure.

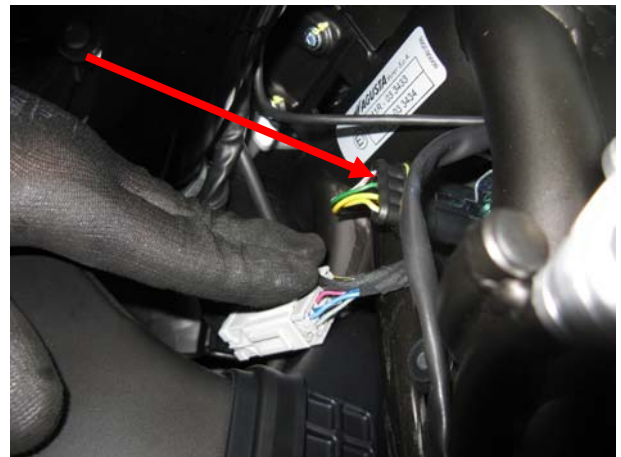
- Disconnect the key switch connector

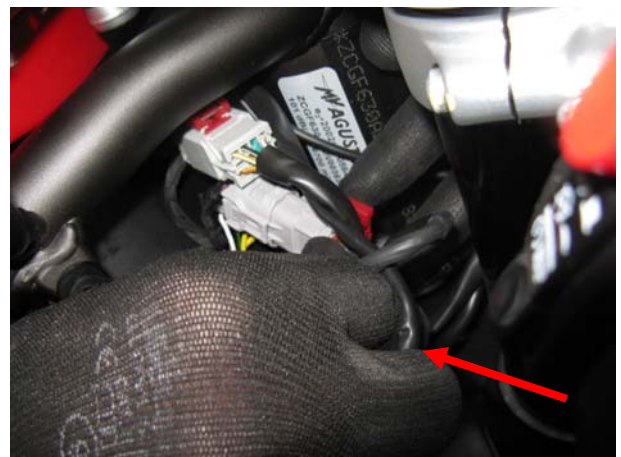
- Now remove the Key Switch, to facilitate the operation we recommend to identify the key switch cable on the right side of the steering column and cut it.

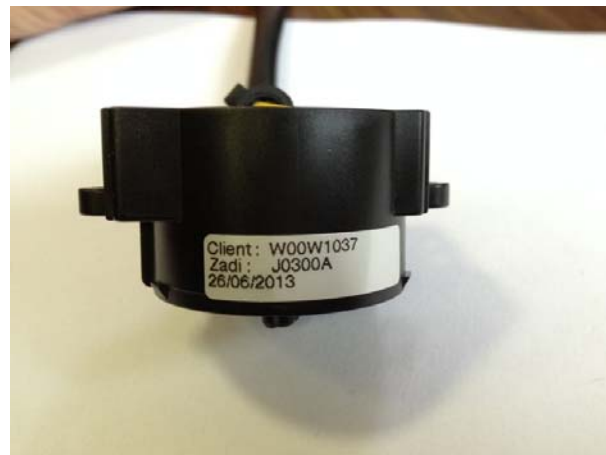
- Take the new key switch part number W00W1037 "PARTE ELETTRICA ZADI" identified by the label as shown in figure and proceed with the installation of the component by inverting the disassembly operations previously described.

- If necessary turn the key in order to find the correct timing..

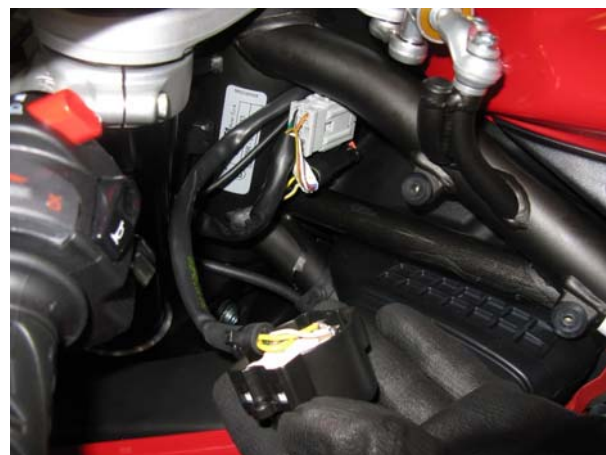
- Position the key switch cable between the airbox and the connectors group

- Insert the key switch in place and fix the cover with the 2 screws previously removed.
- Reassemble the motorcycle completely.
- Please refer to the Service Manual for any information not included in this document.
