# Service Bulletin

Subject: Gear Sensor

Product: **B3 - F3**

- Brutale 675 – Brutale 800 – F3 675 – F3 800

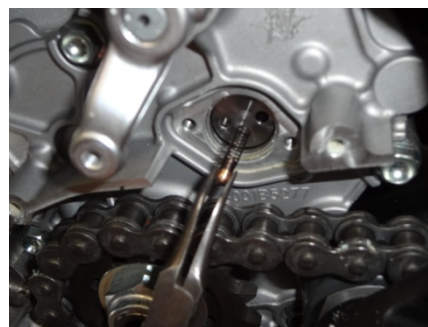
- Remove the old sensor from the engine
- Remove the pin and the pressure spring

**Following a constant surveillance on the quality of our product, we have detected possible irregularities in the functioning of the gear sensor. In the event of incorrect gear indicated in dashboard, it is necessary to replace the gear sensor.**

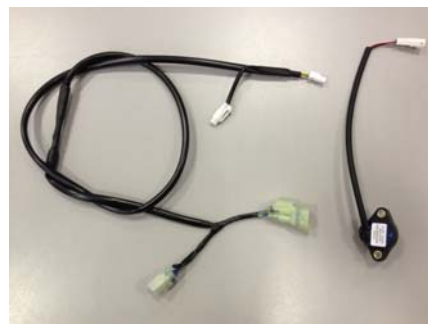
- Recover the O-ring seal from the old sensor

- Take new gear sensor kit 8000B8970

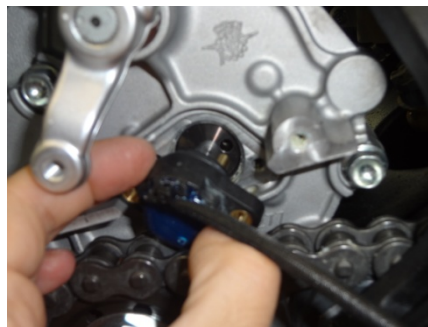
- Install the O-ring on the engine and mount the new sensor with leads upward, taking care to engage the reference peg in the hole of the gear selector.

- Install the 2 screws and tighten to 6-8 Nm, apply medium strength Loctite.
- Collect additional wiring included in the kit
- Connect the speed sensor wiring the kit and the connector to the electrical system of the motorcycle.
- Secure the wiring kit to the chassis using the existing cable ties up to the diagnostic connector in the back of the motorcycle.
- Connect the new wiring kit to the 4-way connector of the diagnostic socket
- Put the protection cap on the spare connector on the wiring Kit
- Complete the motorcycle in its entirety.
- For anything not mentioned refer to the workshop manuals.
- Try the motorcycle on the road before returning to the customer to verify the correct operation
